Durability of PVC Roofing Membranes - Proof by Testing After Long Term Field Exposure

H.R.Beer, A.H.Delgado¹⁾, R.M.Paroli¹⁾, S.P.Graveline²⁾
Sarnafil International AG,
Industriestrasse, CH-6060 Sarnen, Switzerland
hans-rudolf.beer@sarna.com

TT2-157

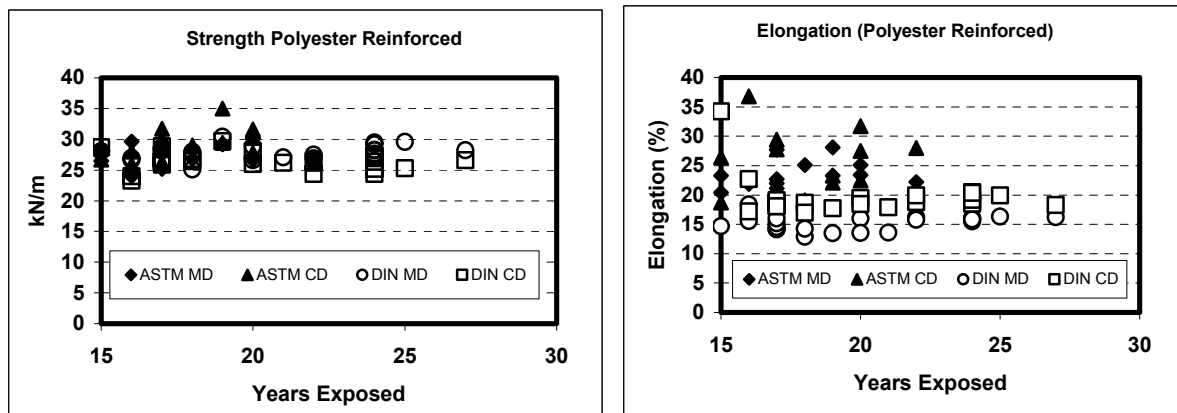
Figure 1: Tensile strength (left) and elongation at break (right) of polyester reinforced membranes versus age

Test data for all the polyester reinforced samples, for both machine and cross directions, is shown in Figure 1. The North American samples were tested according to both the ASTM and DIN test procedures, while the European samples were only subjected to the latter.

None of the North American samples met the minimum breaking strength requirement (35 kN/m) as stated in ASTM D4434 except Sample 13A in the cross direction. The samples retained 70-90% of the minimum breaking strength required for new membranes as specified in ASTM D4434 and over 60% of the samples retained more than 80% of that requirement. Note at the time the membrane was made for most of these projects the ASTM Standard did not exist.

All of the samples, European and North American exceeded the minimum requirements of the DIN standard for new materials (16 kN/m), by 60% to 75%.

The German requirement (16 kN/m) is less than half of the American minimum (35 kN/m). It is interesting to note however that despite the different test methodologies, the tensile results for a given sample correlate remarkably well between the two standards. Additionally, as can be seen in Figure 1, there is little variation in tensile strength as the membranes age beyond 15 years. It would appear that the polyester reinforcement is well encapsulated within the PVC matrix and is therefore very effectively protected. As mechanically attached membranes are subjected to countless cycles of wind uplift over their service lives, the maintenance of high tensile strength is a critical factor in the long term performance of these membranes.

All the North American samples exceeded the minimum elongation at break value (15%) specified within ASTM D4434 for new material. All samples exceeded the minimum requirements of the DIN standard for new membranes (10%). As can be seen in Figure 1 however, unlike the tensile data, the elongation values generated by the two test methodologies do not correlate very well. The ASTM method appears to yield consistently higher results than the DIN test. The ASTM procedure not only results in higher values but also significantly greater data scatter. The DIN data conversely is quite consistent.

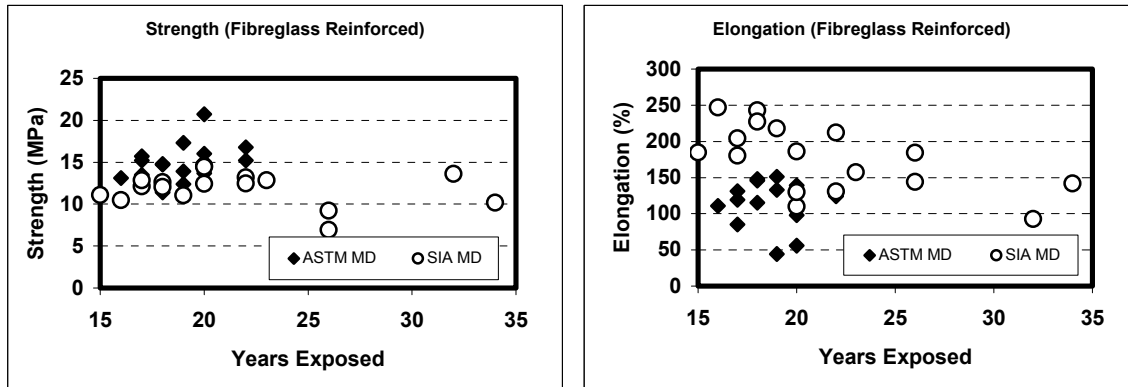
Figure 2: Tensile strength and elongation at break of glass mat supported membranes versus age

As would be expected, the membranes supported by the light weight, glass mat behave differently under tensile load than the much stronger polyester reinforced sheets. The glass mat in these membranes is there simply to insure dimensional stability. These membranes have the lowest level of shrinkage of any single ply membrane on the market. Test data for all glass mat supported samples is shown in Figure 2.

thickness of the sample (i.e. greater strength with increasing membrane thickness), data is reported in MPa. All North American samples exceeded the ASTM minimum requirement for new material (10.4 MPa). The tensile strength of all the samples was greater than the DIN minimum (8 MPa). As can be seen in Figure 2, there is a tendency to increased tensile strength with age in the 15 to roughly 23 year range. This is expected as the sheet loses some flexibility over time. Beyond that range, there are insufficient data points to observe a clear trend.

A minimum elongation at break value of 250% is required for new materials in ASTM D4434. The measured elongation at break for the North American samples ranged from 45-150%, which corresponded to 18-60% of the minimum value specified for new materials. Samples 4B, 5B, 8A, and 20B had significantly lower elongation at break values (18-40% of ASTM minimum) than the rest (44-60% of ASTM minimum). The reasons for these values are not clear at this time. The DIN standard calls for new membranes to achieve a minimum of 150% elongation at break. As can be seen in Table 6.3, 4 of the 7 European samples achieved this value, one sample was at 95% of this value and another was at 92% of it (in the machine direction). Overall 11 of 17 samples (European and North American) surpassed this requirement for new products. Even amongst the samples with the lowest elongation values, all of the roofs were performing at the time of the survey and none showed any signs of any distress.

As can be seen in Figure 2, there is no correlation between the elongation data generated by the two different test methods. With the glass mat sheets, the SIA procedure results in higher values than the ASTM method, in many cases significantly higher. Once more, the different test parameters are assumed to be the reason for the differences. Perhaps not unexpectedly, for both types of membranes, the testing conducted at the lower cross head speed yields the higher elongations at break.

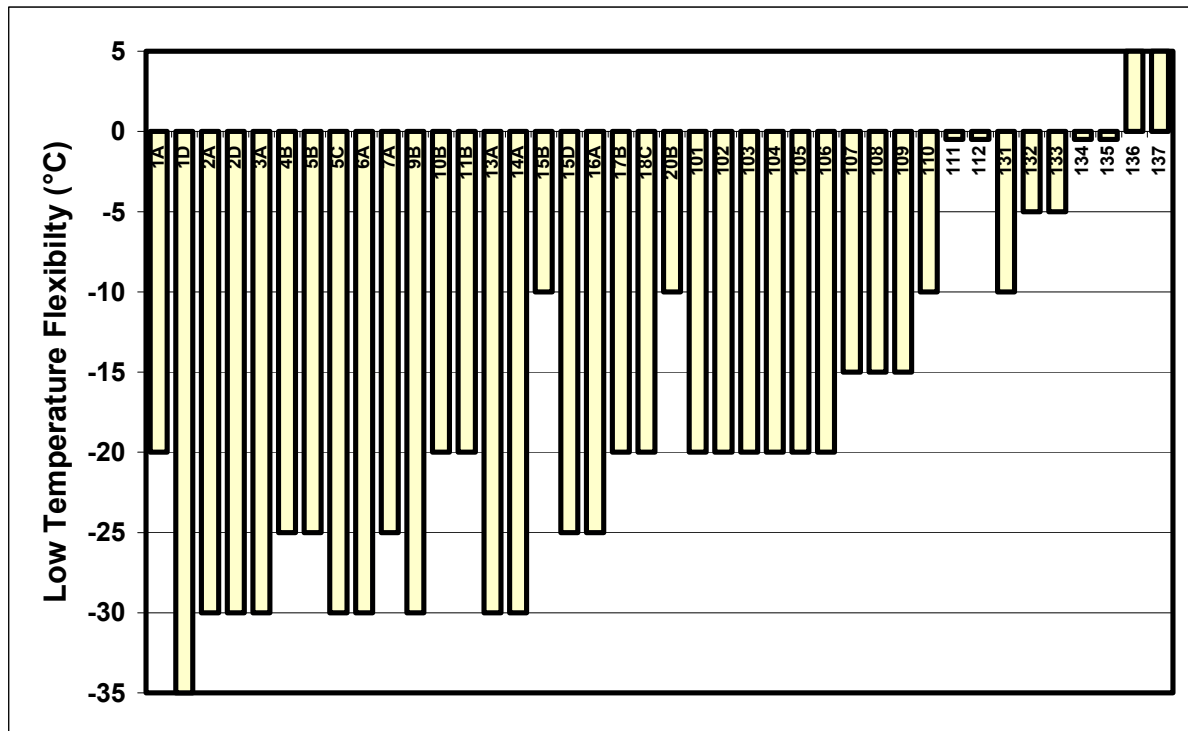
Figure 3: Low temperature flexibility data

Flexibility is an important membrane property, particularly during the application phase. The flexibility of all types of roofing membranes decreases with temperature. For this study, the membranes' low temperature flexibility (LTF) was tested according to the procedure outlined in SIA 280. Five 10 mm wide rectangular specimens are folded with a bending radius of about 15 mm and fixed between two metal plates. The test device is then stored in a chamber and allowed to cool to the desired test temperature. When the samples have reached the required temperature the device is removed from the freezer and the two metal plates are instantly and quickly pressed together so that the samples are bent to a radius of 5 mm. The lowest temperature at which all five specimens do not break or crack is recorded. The reproducibility of the test method is $\pm 5^{\circ}\text{C}$. The SIA 280 requirement for new material is -20°C . Test results are summarised in Figure 3.

Remarkably 25 out of 40 samples still fulfill the requirement for new materials according to the SIA requirement of -20°C or lower. Even the two samples with the highest values of 5°C still show considerable flexibility. The testing conditions (rapid 180° bending around a small radius) are obviously severe and do not occur in real roof conditions. Membrane flexibility is an issue mainly during installation and roof maintenance. As can be seen even the aged installed membranes with a LTF value of 5°C continue to perform.

The fact that a majority of all samples are tested with low temperature values above the requirements for virgin material reflects the manufacturer's efforts to formulate their membranes for long term behavior. Potential reduction in plasticizer content over long years of roof service is accounted for by the appropriate formulation of the base vinyl material.
