# Traffic Membrane Troubleshooting Manual

**Technical Manual**

**2024 Edition**

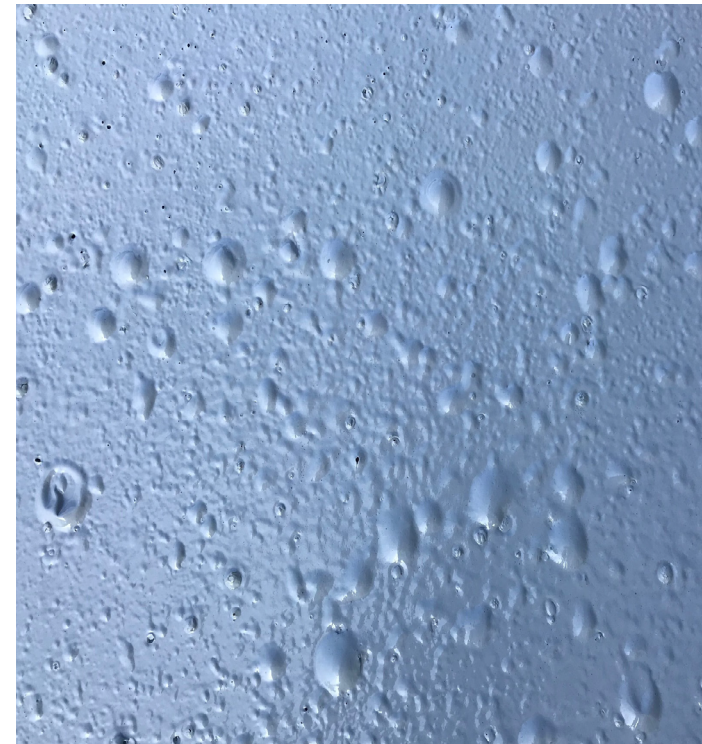
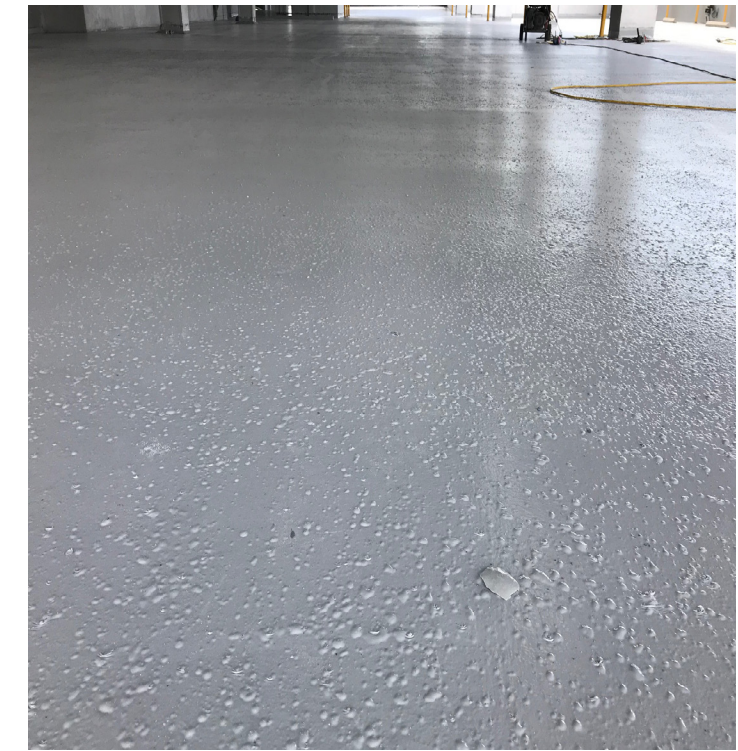
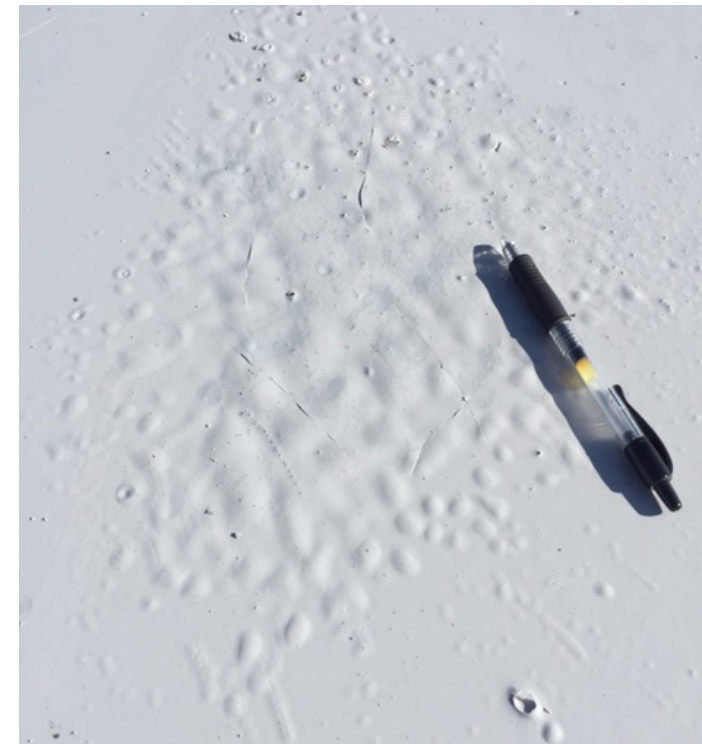
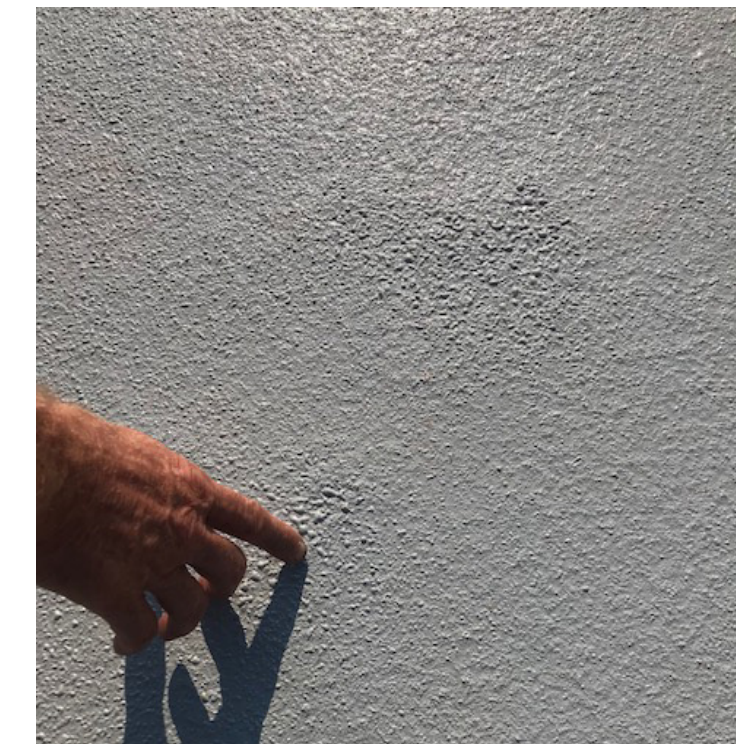
# BUBBLING DUE TO ENCAPSULATED MOISTURE IN THE SUBSTRATE

Bubbles in the coating surface which have not popped. When the bubble is cut water comes out or the surface underneath the bubble is wet.

- High surface moisture content prior to application of membrane
- Trapped moisture in insulated split slab construction
- Trapped moisture in metal pan deck construction
- Application during winter months – problem may not appear until the following summer when temperatures rise drawing moisture in the slab to the surface
- Water contamination prior to application of the coating ( rain )
- Application above 4% moisture content without using a special moisture barrier

- Completely remove affected area down to the concrete substrate
- Let the surface dry
- Re-apply the system paying special attention to avoid the causes listed above

- Check the substrate moisture content and follow the guidelines if the moisture is higher than 4% by Tramex. One more testing method to check vapor moisture drive strongly is recommended (plastic sheet test)
- Determine if the structure is a split slab or metal pan deck
- Check the dew point and ensure you are a minimum of 5F above the dew point
- Avoid outside application during late fall or winter (what about our winter grade?)
- Minimum temperature and humidity should be within the range specified in PDS
- If ambient conditions are critical apply the product during falling temperatures

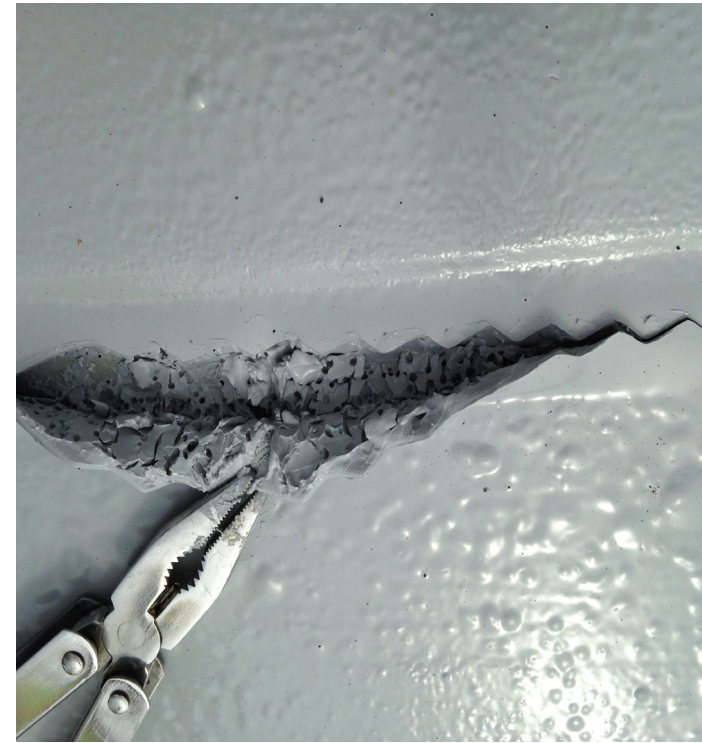
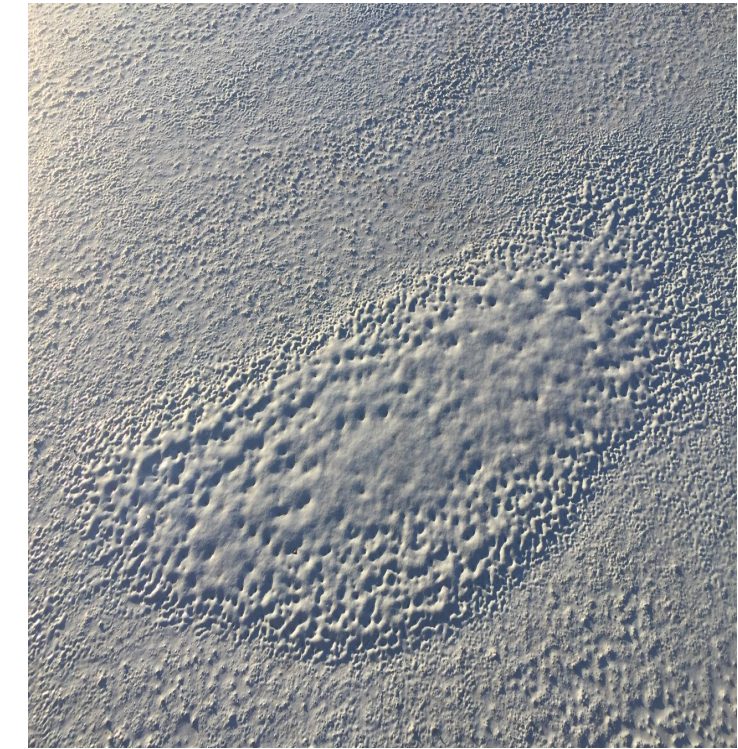
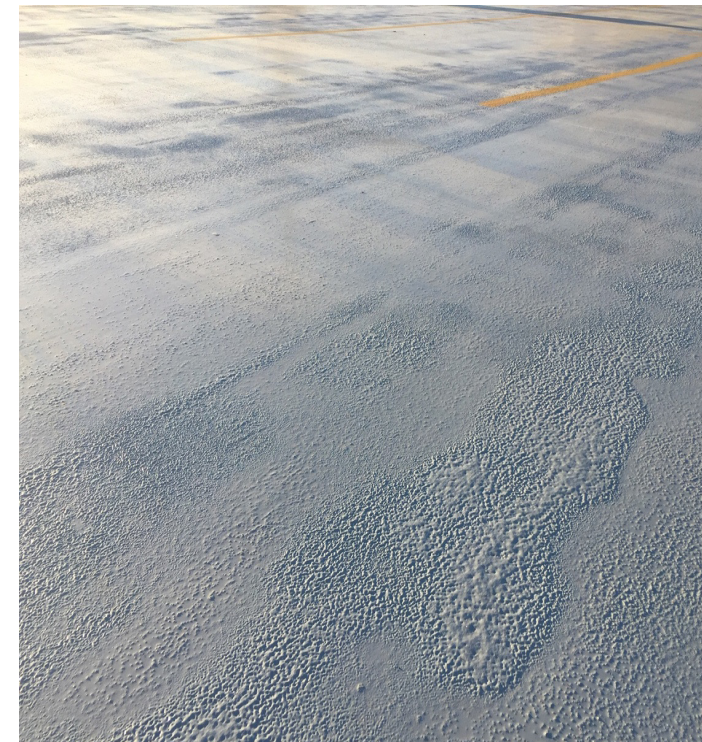
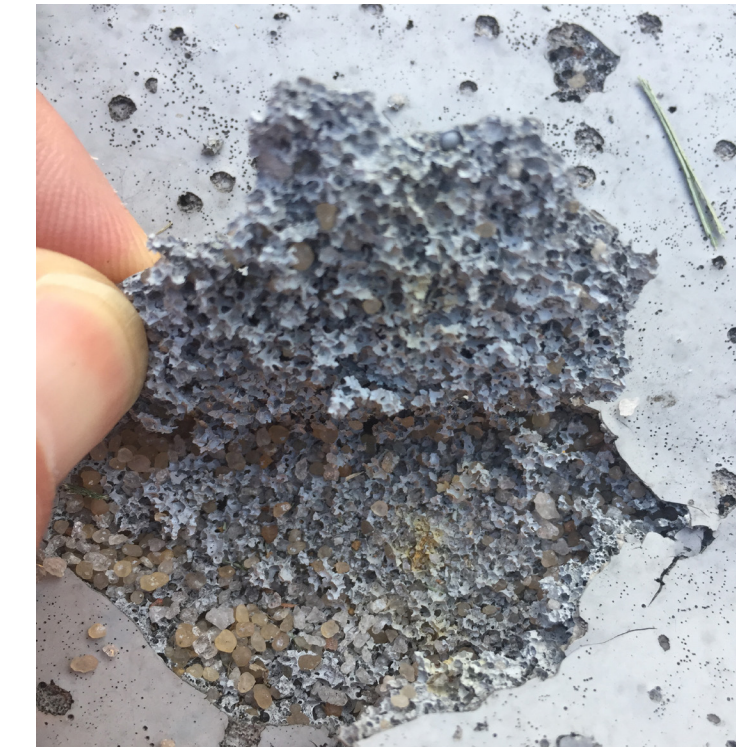
# BLISTERING DUE TO THICK COATING

These blisters feel spongy and the coating is usually very thick and soft. When the blister is cut the coating is excessively thick and may be as much as 60-120 mils (DFT) thick and looks like a sponge with unbroken or circular blistering. It happens mostly to top coats especially single component top coats. The affected coating wears very quickly and aggregate usually settles completely into the coating leaving a smooth surface.

- Wet film application is too thick
- Wrong tools ( squeegee size)
- Wrong detail work
- Uneven surface - low spots
- Very rough concrete surface profile ( more than CSP 4 )
- Insufficient mixing of single component product

- Remove affected area down to sound substrate
- Re-apply the coating

- Check the wet film thickness during application
- Detailing - Fill up low spot areas of the substrate prior to application
- Detailing - Check CSP ( CSP 3-4 required )
- During application backroll to move the material from low spot areas
- Check your tools - use the recommended size squeegee
- Use a booster or accelerator with single component products

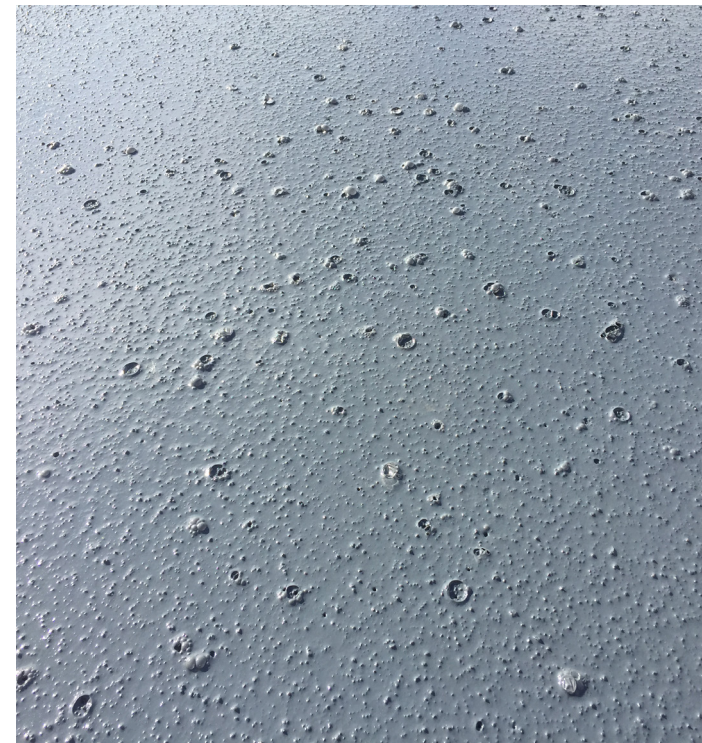
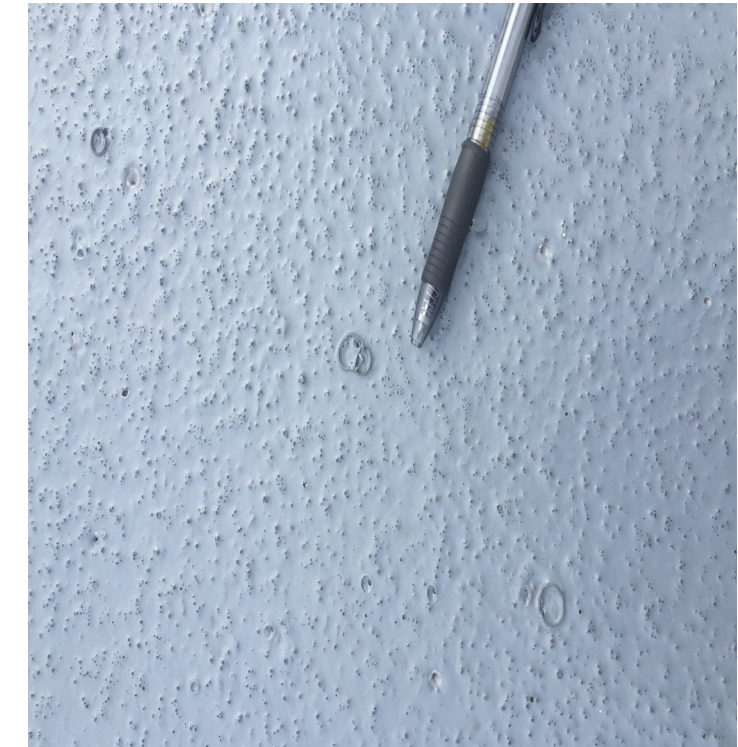
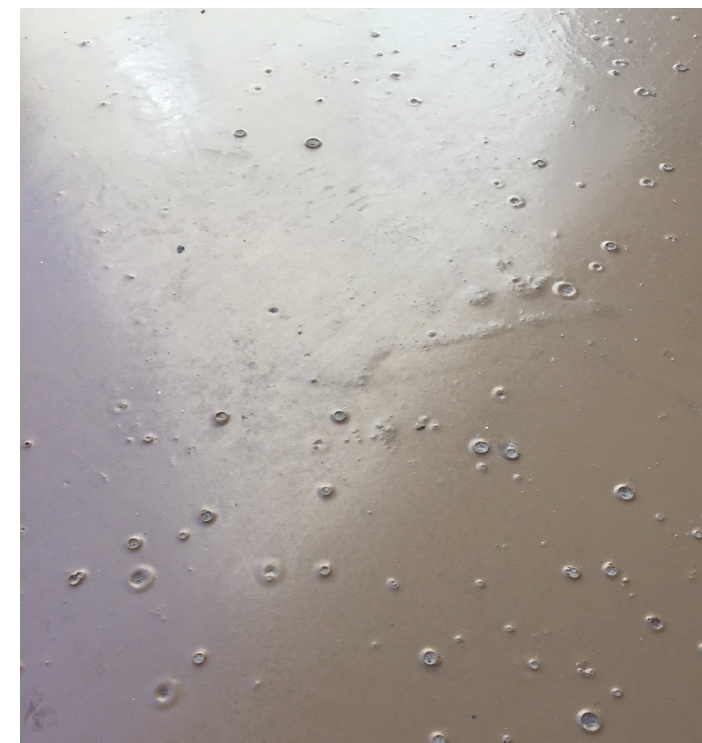
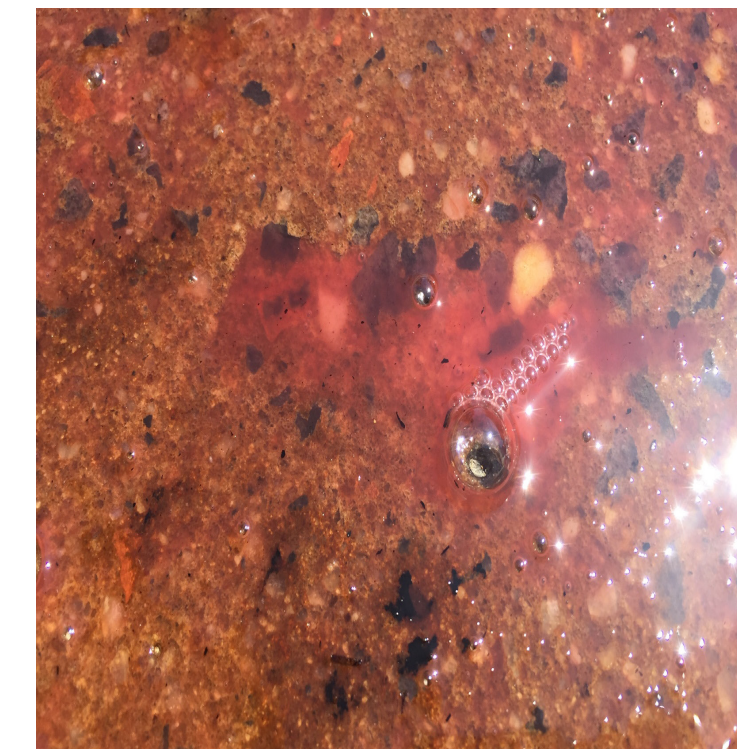
# PINHOLING / BUBBLING

Pinholing is a result of outgassing when air escapes from porous concrete and becomes trapped in the coating. As the air escapes through the coating, the first sign is generally small bubbles that appear shortly after the application of the coating. When the bubbles pop they leave behind small craters in the coating. The pinhole can usually be seen at the bottom of these craters.

- Porous concrete surface
- Insufficient primer application
- Aggressive surface preparation
- Moisture ( damp substrate )
- High ambient temperature (rapid curing )
- Freshly applied coating exposed to direct sunlight
- High substrate temperature at 90°F and above

- Lightly grind or sand affected areas to a flat finish
- Apply 100% solid epoxy primer and seed it lightly (10lbs/100sf) with 20/40 dry silica sand
- Clean to remove excess sand
- Re-apply base coat or the whole system

- Prime substrate precisely following required coverage rate
- If substrate is very porous or rough, 2 coats of primer are strongly recommended
- Avoid aggressive surface preparation
- Consider application in afternoons or evenings as temperatures are falling in order to avoid rapid temperature increase during application
- Prevent direct sunlight exposure during initial cure
- Temperature and humidity should be within the range specified in PDS
- At the first appearance of bubbles a spike roller can be used to pop the bubbles
- Check substrate moisture and follow the guidelines if the moisture is higher than 4% by Tramex.

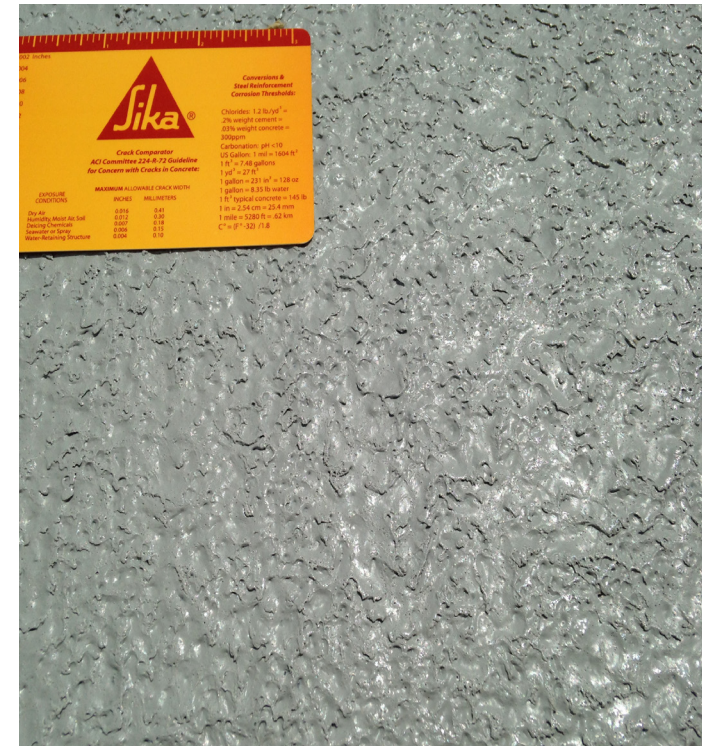
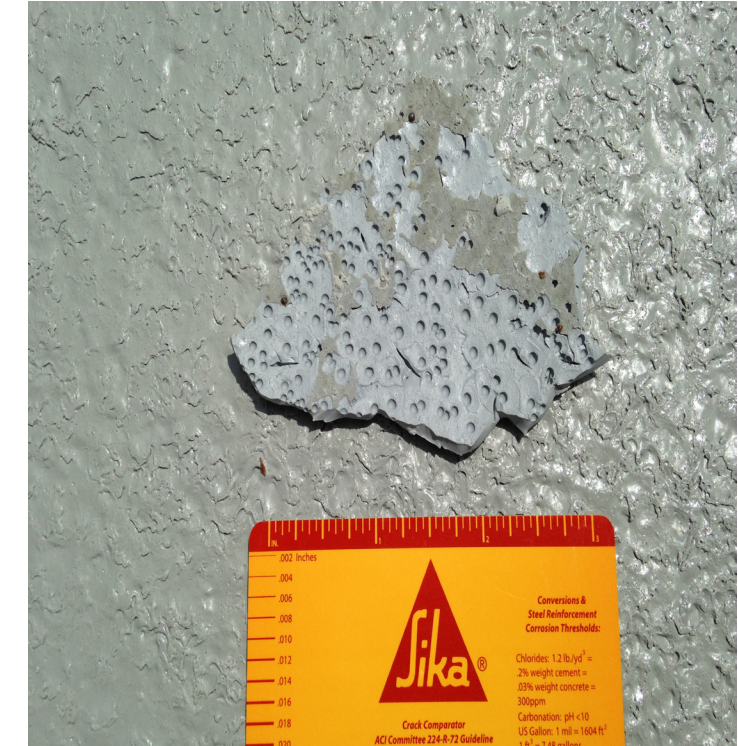
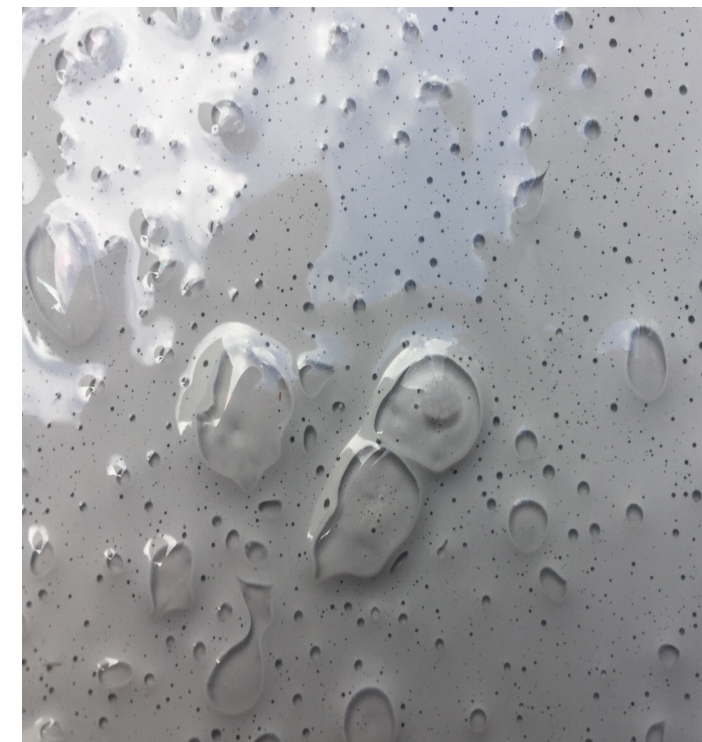
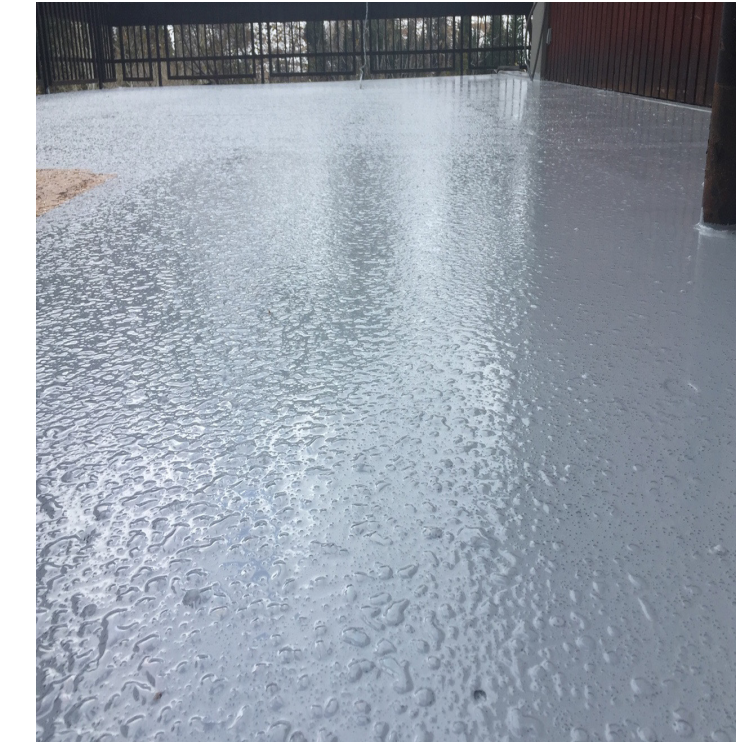
# WATER DAMAGE

Water damage occurs as a result of deterioration of the membrane before the material has fully cured. This occurs when there is poor membrane adhesion due to the presence of water or dampness during the application.

- Inclement weather during application (Rain, Snow)
- Accidental water leak (floors above, sprinklers)
- Human sweat
- Contamination by machinery liquids

- Completely remove affected area down to concrete substrate
- Re-apply the system

- Avoid application during or shortly before anticipated inclement weather
- Protect the area from any potential accidental water leak from the floors above
- If possible, sequence the project from top levels to lower ones
- Workers should wear heats or head bands
- Deactivate sprinkler system prior to application

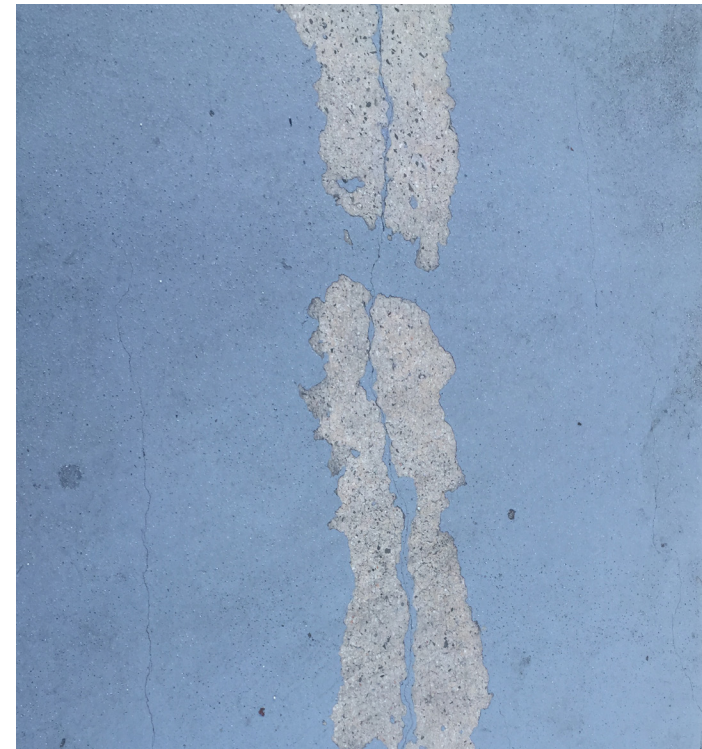
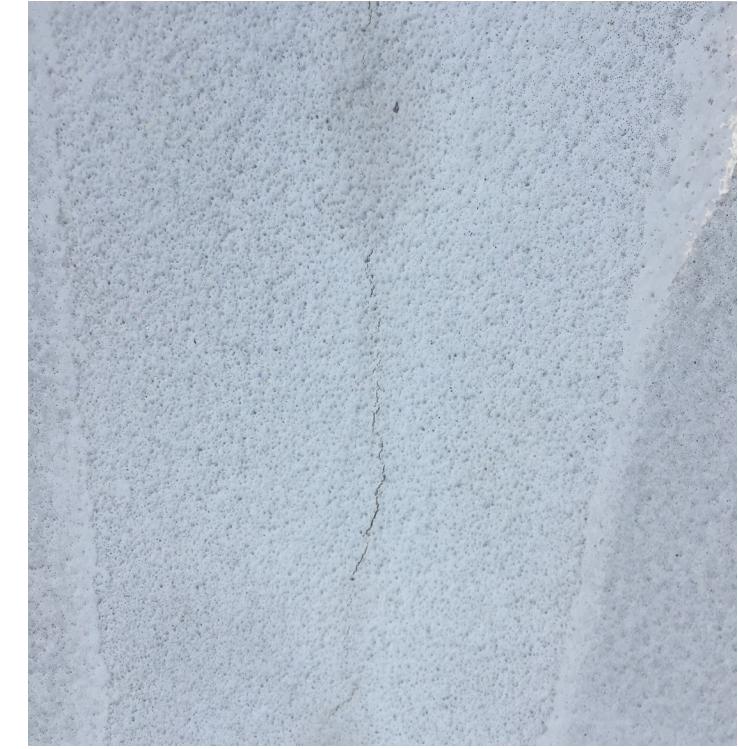
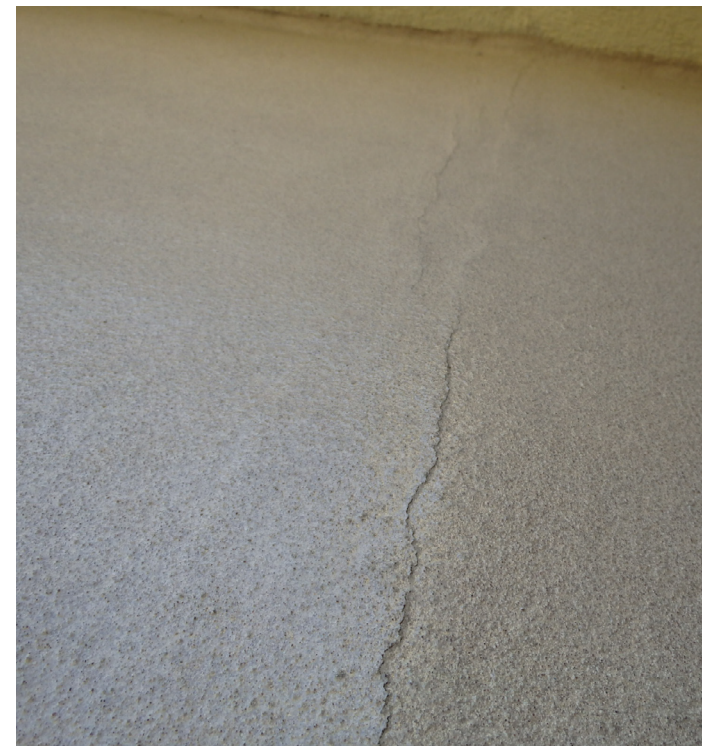
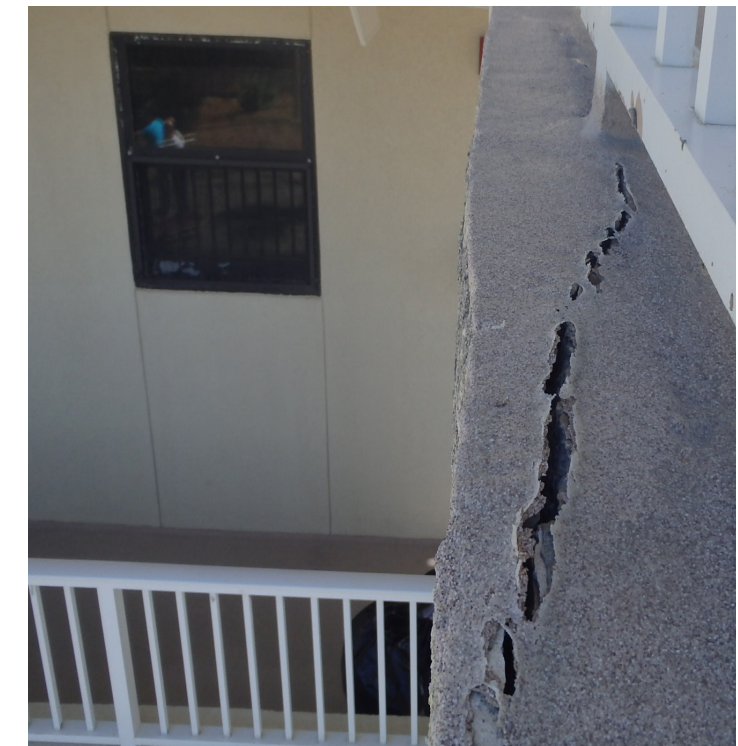
# CRACKS / JOINTS

Substrate fractures which telegraph through the membrane caused by excessive movement. Cracks may compromise the waterproofing system causing leaks affecting water tightness of the system if not properly treated.

- Structural problem - movement in the joint exceeds elongation of membrane
- Failure to route, caulk and detail every crack greater than 1/16"
- Failure to detail every crack which is less 1/16"
- Uncured sealant in routed and caulked crack
- Coating over joints greater than 1"
- Cracks in the concrete occur; especially in new construction, after the basecoat was applied

- Route existing cracks and seal with a polyurethane sealant
- Apply detail coat
- If excessive movement is expected reinforce detail coat with Sika Flexitape heavy or run the sealed joint through the traffic membrane

- Properly detail cracks
- The correct crack treatment will depend on crack width and expected movement
- Honor joints greater than 1" thorough the system
- The strip of detail coat 23 DFT should be always applied
- Use only PU sealant under PU waterproofing membrane
- Use reinforcement if movement creates crack up to 1/16 inch
- Rout and seal if movement creates crack between 1/16 inch to 1 inch

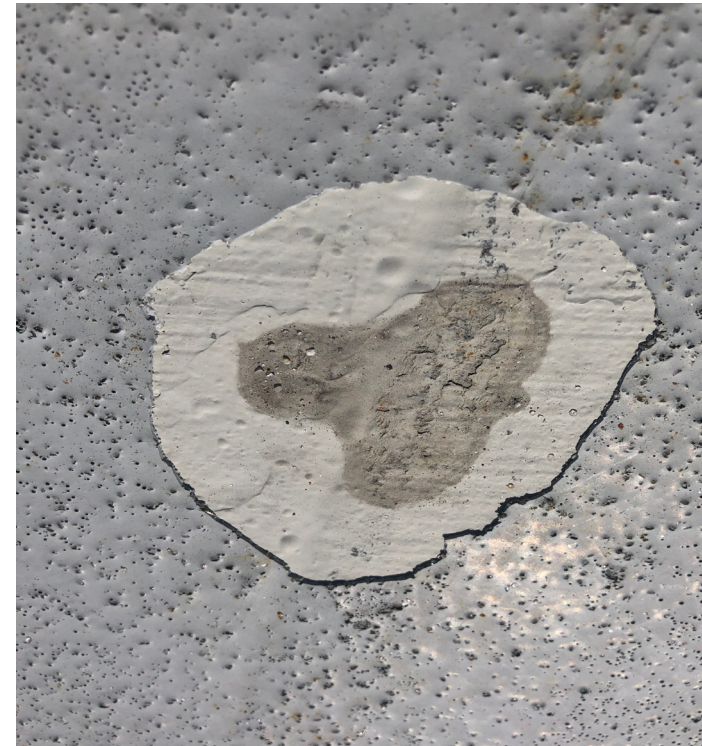
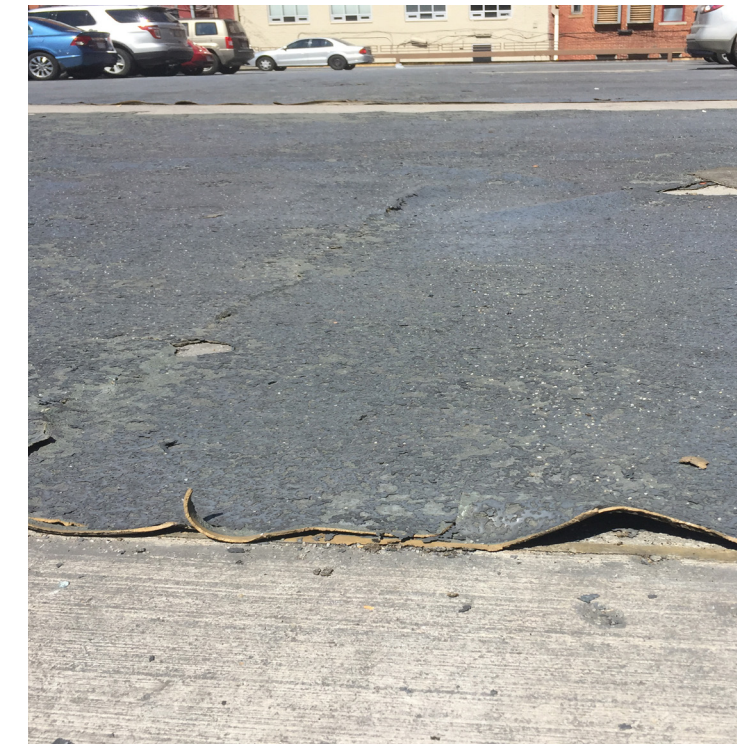
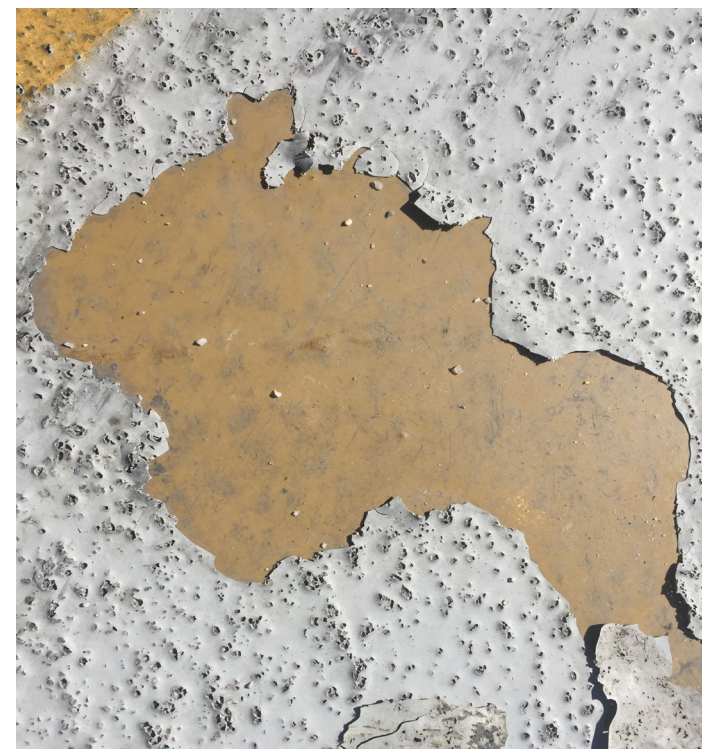
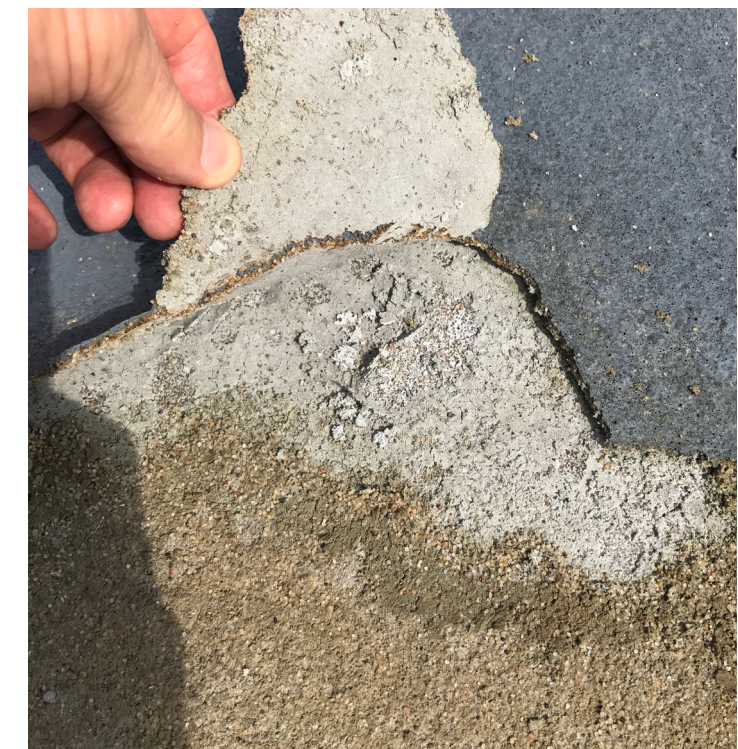
# DELAMINATION / PEELING

The coating peels off the substrate ( concrete ) or previous coat (inter coat adhesion).

- Insufficient concrete surface preparation ( suitable CSP )
- Existing coating preparation ( grinding, roughening, recoat window, cleaning, primer )
- Surface contamination ( dirt, dust, oil )
- Moisture ( damp substrate, dew point , sweat )
- Insufficient thickness ( min. DFT )
- Not properly maintained ( snow plows, aggressive cleaning agents, chemical impact – car liquid leaks )

- Remove loose delaminated coating
- Abrade and clean surface
- Remove all residual contamination (chemically or mechanically)
- Reapply the whole system or top coat using appropriate primers

- Follow PDS recommendations
- Surface preparation : Abrade or shot blast the substrate to achieve a CSP 3-4 per ICRI guidelines
- Surface contamination : Entirely clean substrate prior to application of primer or primerless base coat
- Remove all residual contamination on existing coating (chemically or mechanically)
- Remove all loose areas of existing coating
- Follow required maximum recoat window of new coating
- Follow required minimum coverage rates of each coat
- Check substrate moisture and follow the guidelines if the moisture is higher than 4% by Tramex
- Verify the substrate temperatures are minimally 5F above the dew point

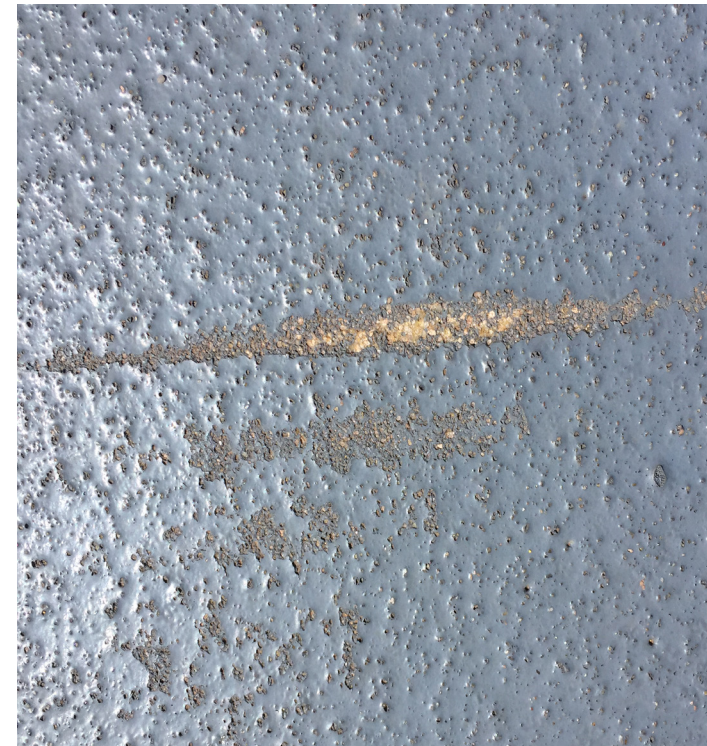
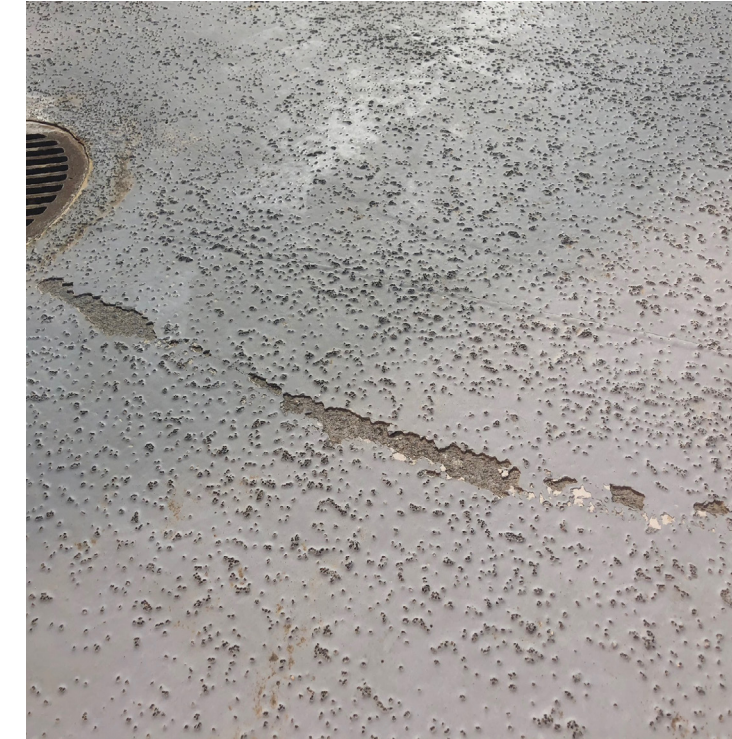
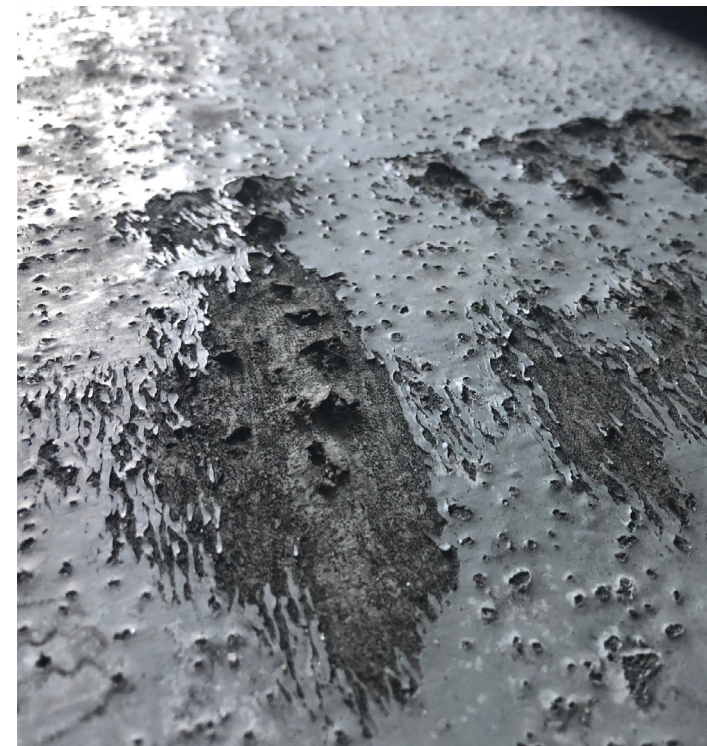
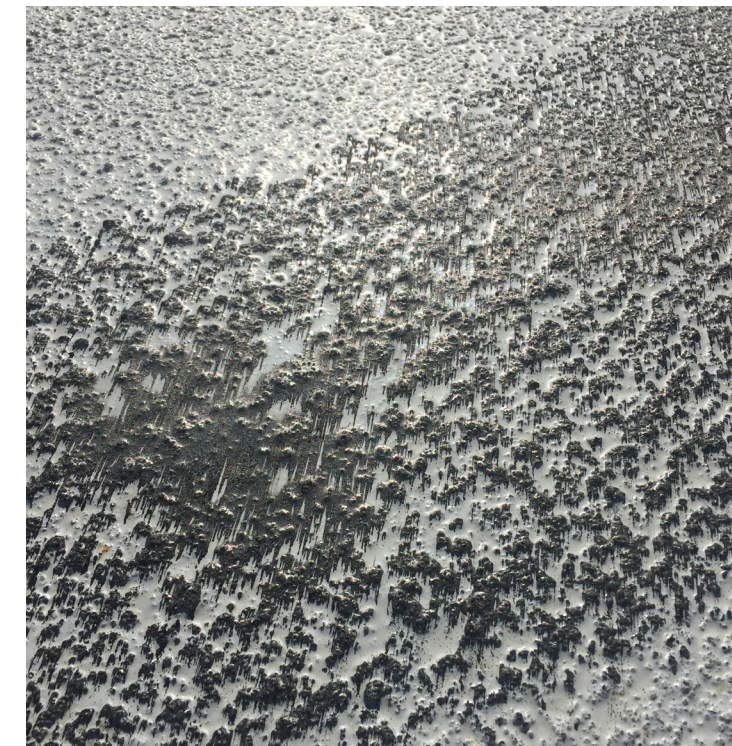
# MECHANICAL DAMAGE

Finished waterproofing system damaged by reckless use and insufficient maintenance .

- Reckless behavior
- Vandalism
- Snow plows
- Studded tires
- Skid marks - burned tires

- Completely remove the affected area down to the concrete substrate
- Re-apply the system

- The system should be periodically maintained
- Installation of speed bumps
- Snow removal equipment should be equipped with adjustable , rubber, snow-plow blades
- Heavy duty systems should be installed on the top deck levels where snow plowing is expected
- Do not use wire brush to clean the membrane
- Use solvent free and acid free cleaners

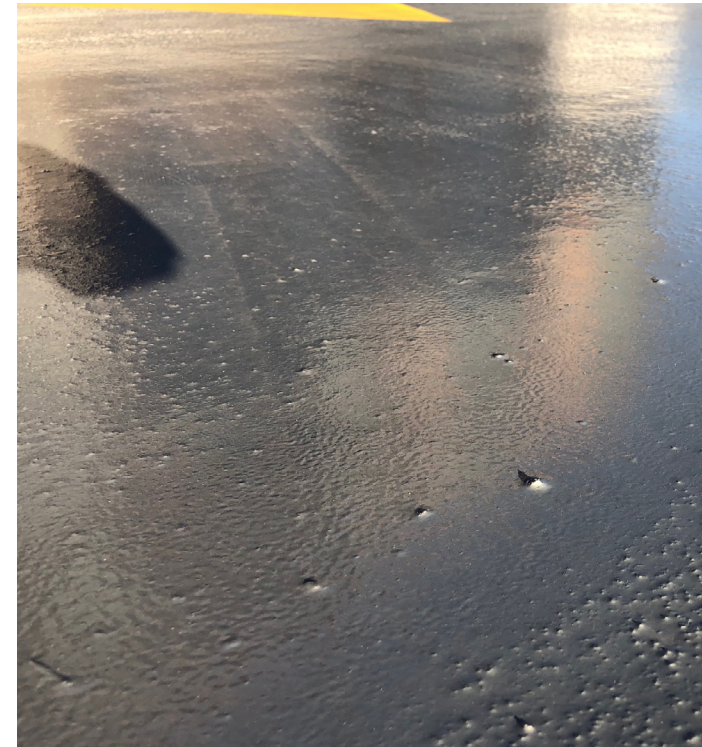
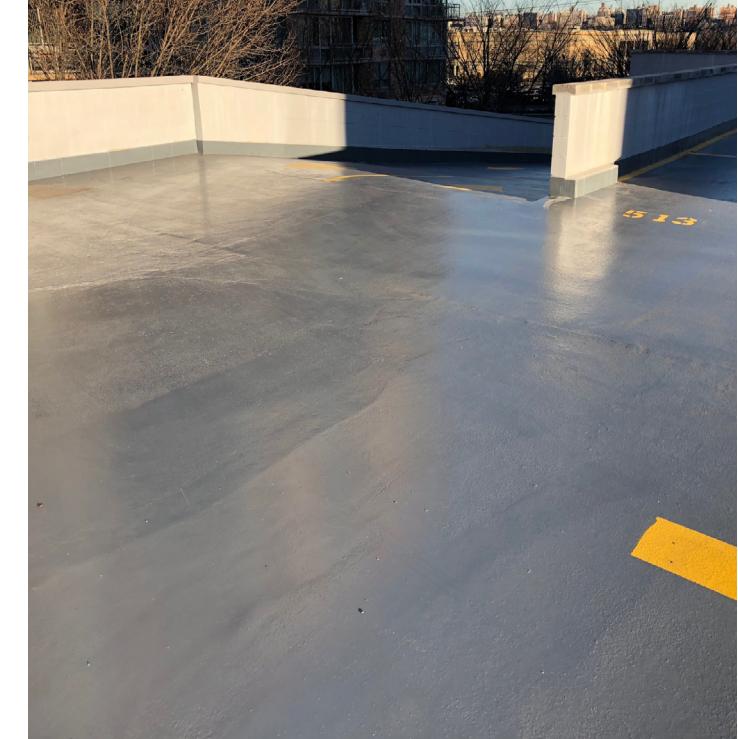
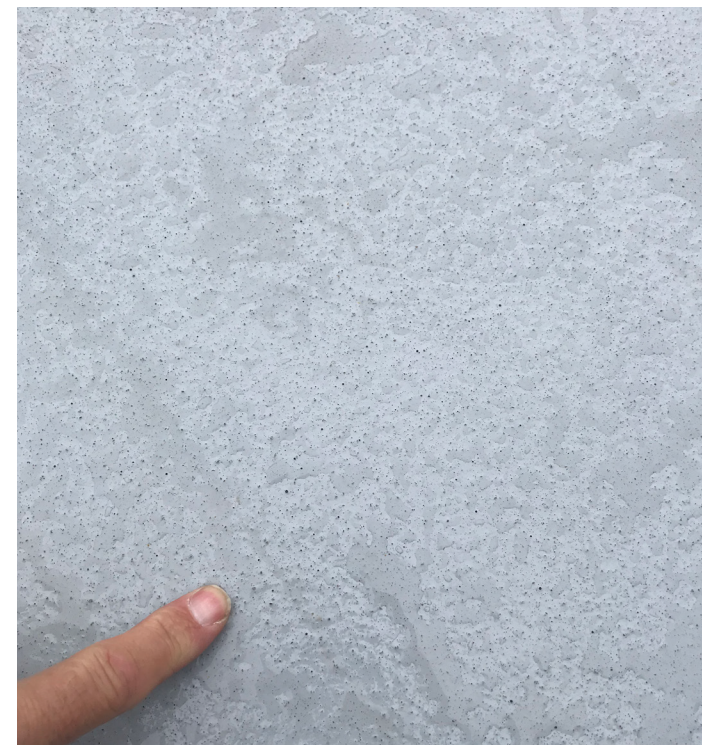
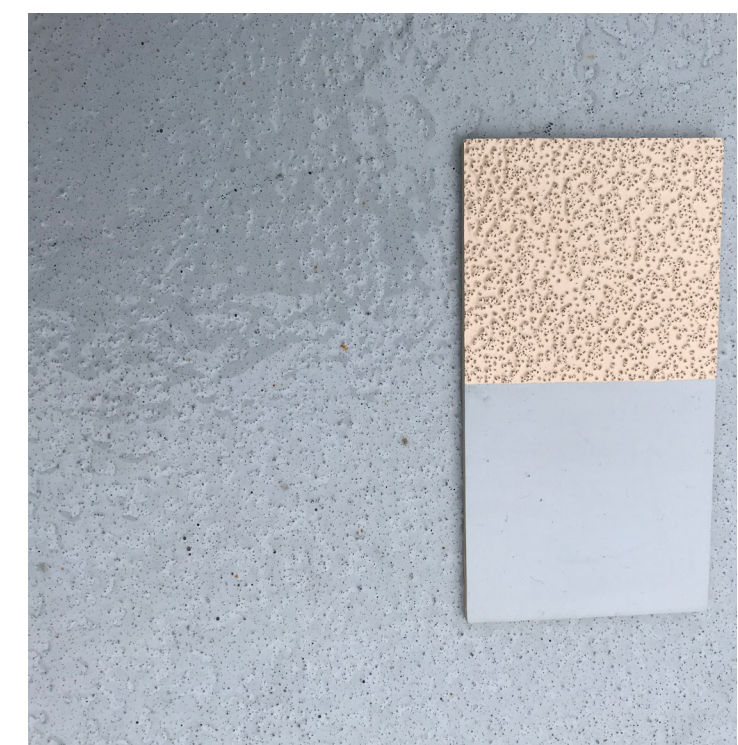
# SKID RESISTANCE / INCONSISTANT TEXTURE

The surface of the finished membrane is slippery and/or there are 'bald' spots. Inconsistently seeded aggregate create bold and shiny spots on the membrane. Wear resistance and aesthetics features are also compromised.

- Inconsistent aggregate distribution
- Insufficient amount of aggregate applied per sf
- Wrong tools (roller) used
- Wrong aggregate size
- Difficult seeding of the areas with bad access
- Seed and back roll may be more prone to inconsistent appearance vs seed and lock

- Abrade the surface
- Clean and apply recoat primer
- Apply 2 coats of wear/top coat and broadcast depending on the type of seeding

- Broadcast sufficient amount of aggregate
- Use the right method based on the traffic and specific project need ( seed & lock or seed & backroll)
- Use more coarse aggregate and adequate amount of resin to enhance slip resistance
- Use the right size aggregate according to manufacturer's PDS
- Use a pretextured topcoat
- Apply two top coats if using pretextured top coat

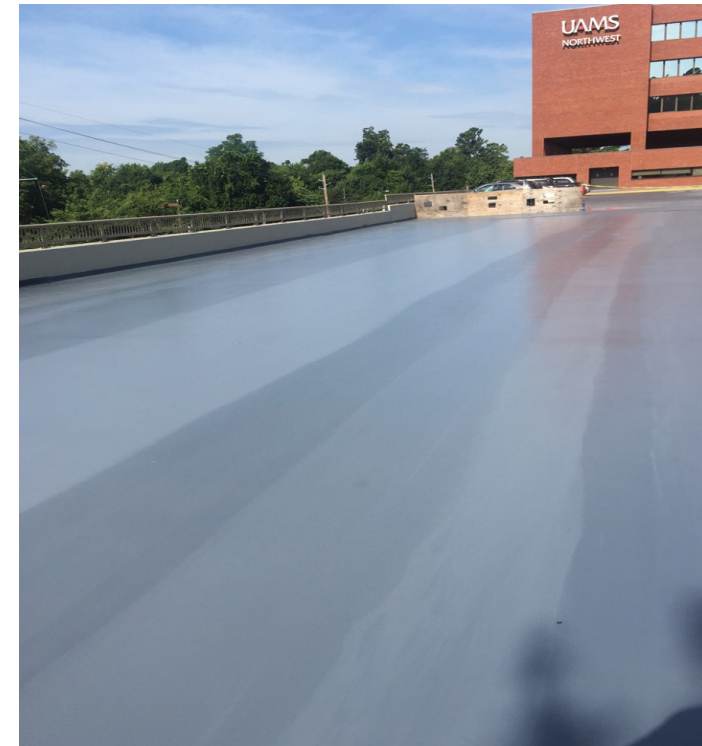
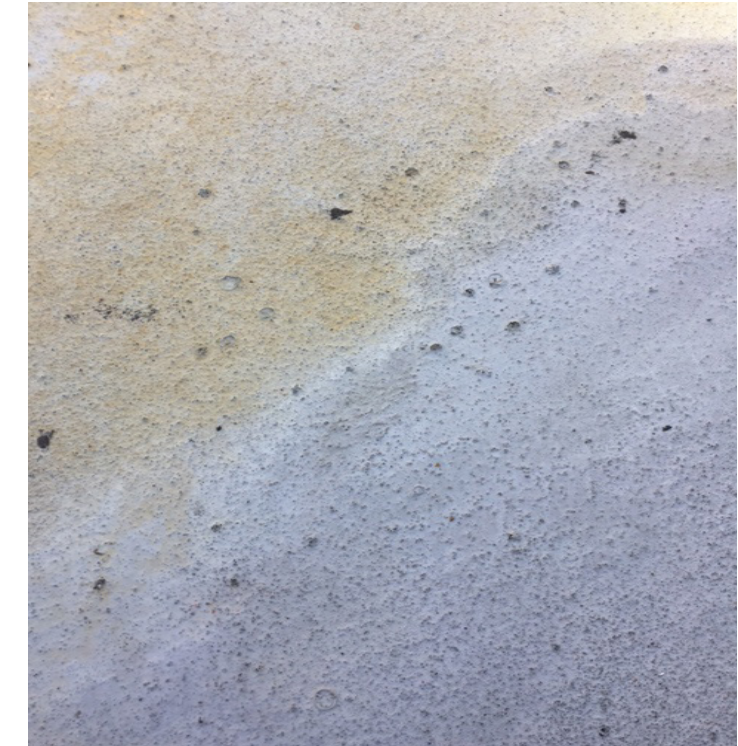
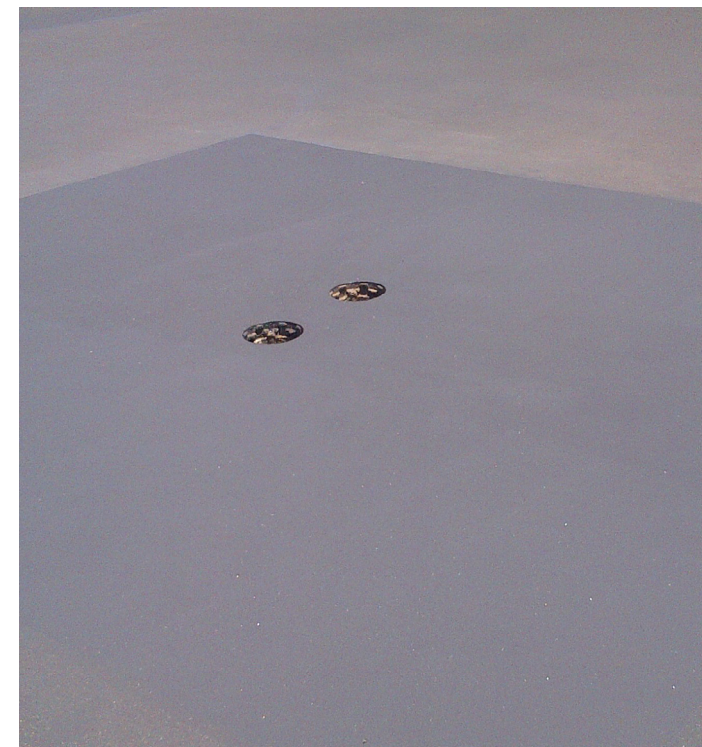
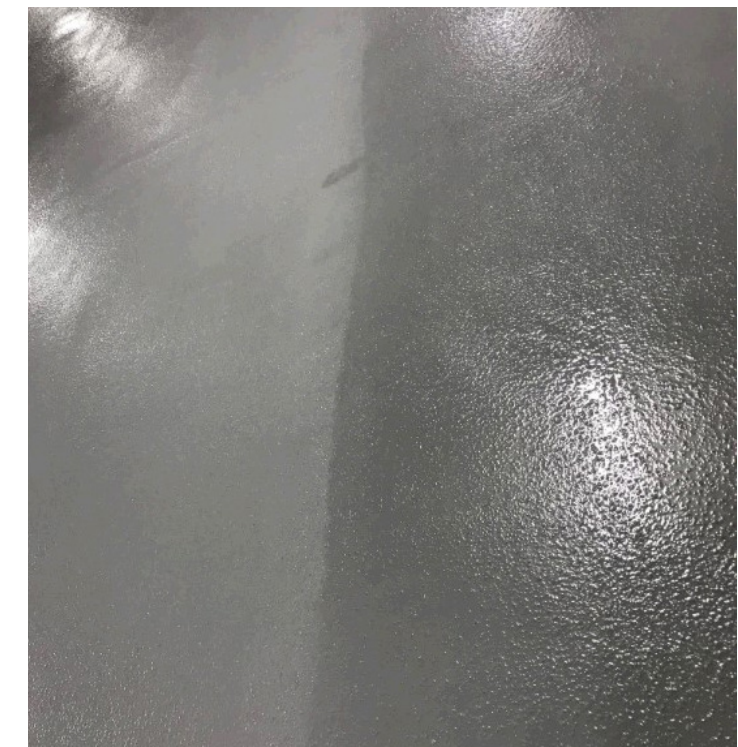
# COLOR VARIATIONS

The coating appears to be different shades.

- Product from different batches can have slight variations in color
- The older coating of the same color has had more UV exposure and has weathered
- No sufficient mixing
- Shaded areas of deck can get less UV exposure and can appear darker

- Clean the whole affected area apply recoat primer Use only one batch of the product for this additional coat.
- Apply additional top coat
- Use only one batch of the product for this additional coat

- Check the batches
- Prior to application ensure that you have enough product from the same batch
- Apply the whole top coat in single application
- Mix product thoroughly 3 minutes
- Scrap the sides of the pail during mixing
- Use aliphatic top coat only for UV exposed areas
