# Traffic Membrane Troubleshooting Manual

**Technical Manual**

**2024 Edition**

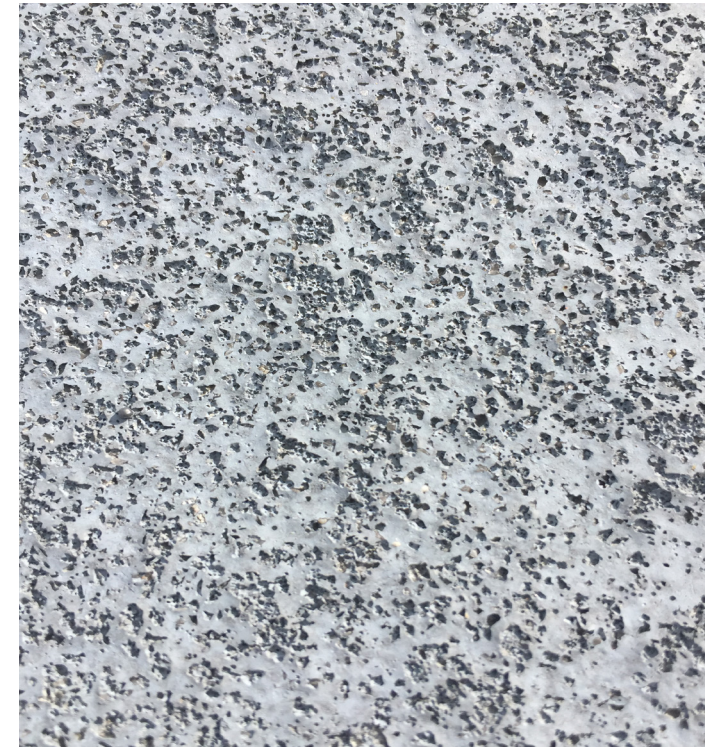
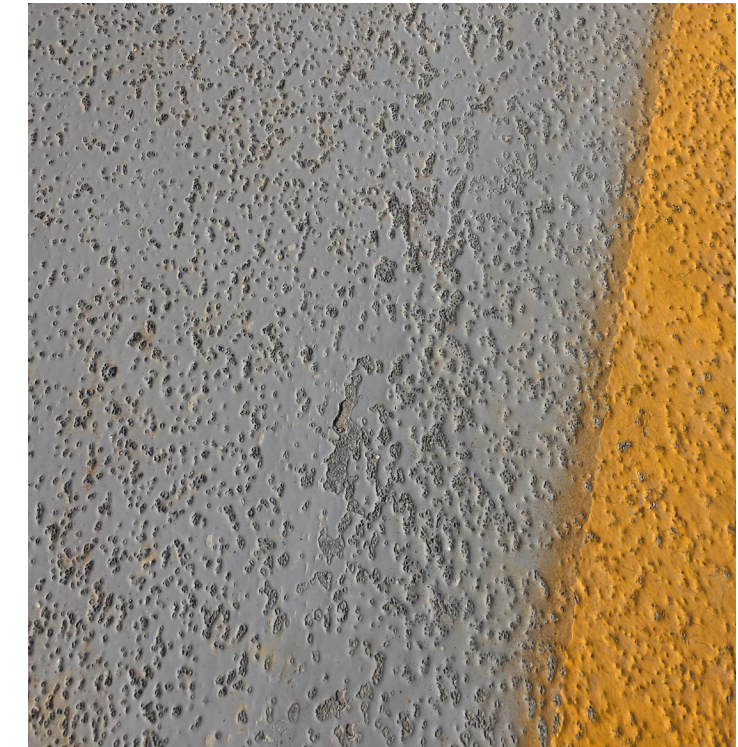
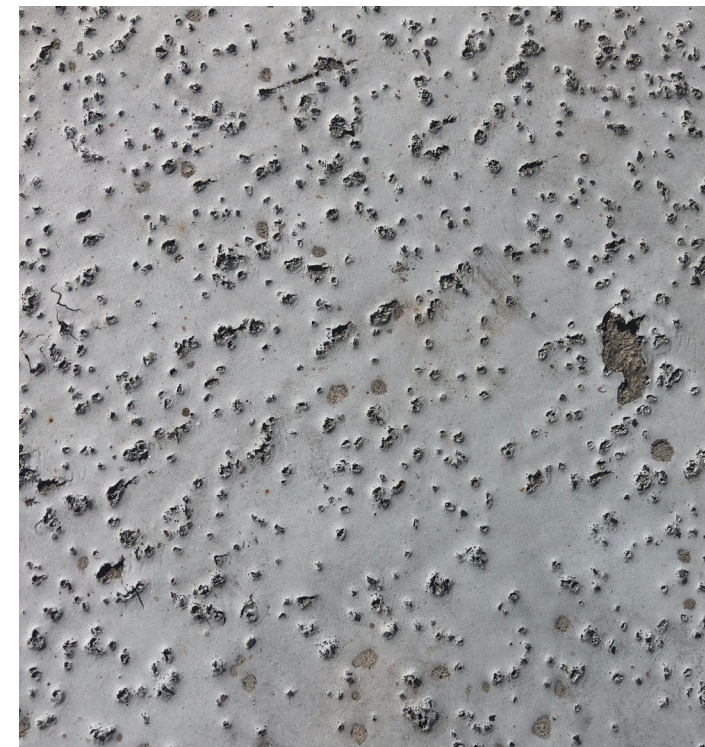
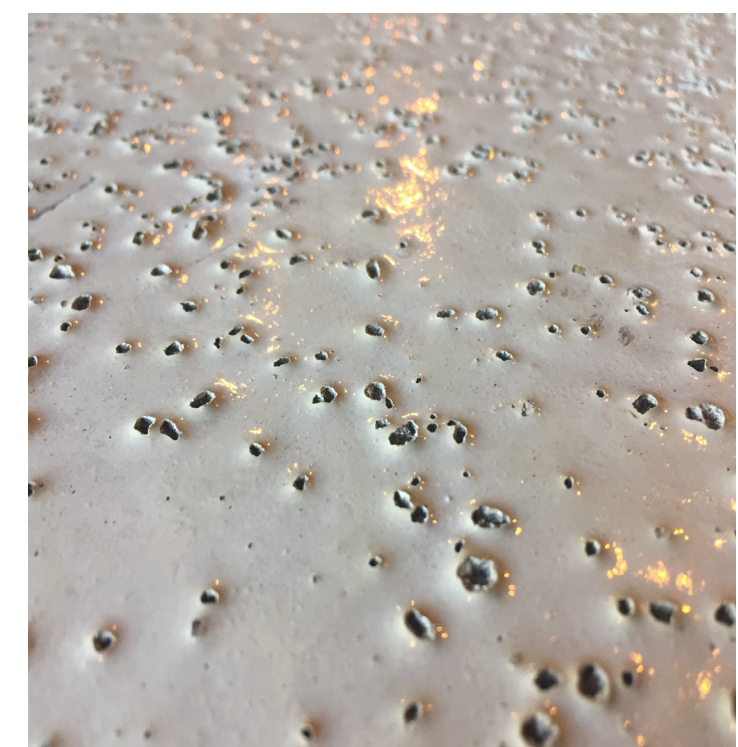
# AGGREGATE ROLLING OUT

The top coat loses significant aggregate after a short period of service.

- Wrong aggregate selection
- Wrong thickness of the top coat - insufficient encapsulation
- Wet or contaminated aggregate

- Clean the whole affected area from all loose aggregate and solvent wipe
- Apply recoat primer
- Apply 2 additional top coats seeded with right aggregate

- Check the source of aggregate and make sure that the aggregate is totally dry
- Aggregate can get wet if packed in plastic bags
- The aggregate should be washed silica sand
- Gradation of aggregate should be between 16 - 40 mesh
- Stock aggregate before application indoors or covered to protect from rain
- Follow the minimum and maximum thickness of the top coat
- Use textured products to avoid an issue with aggregate selection and aggregate condition

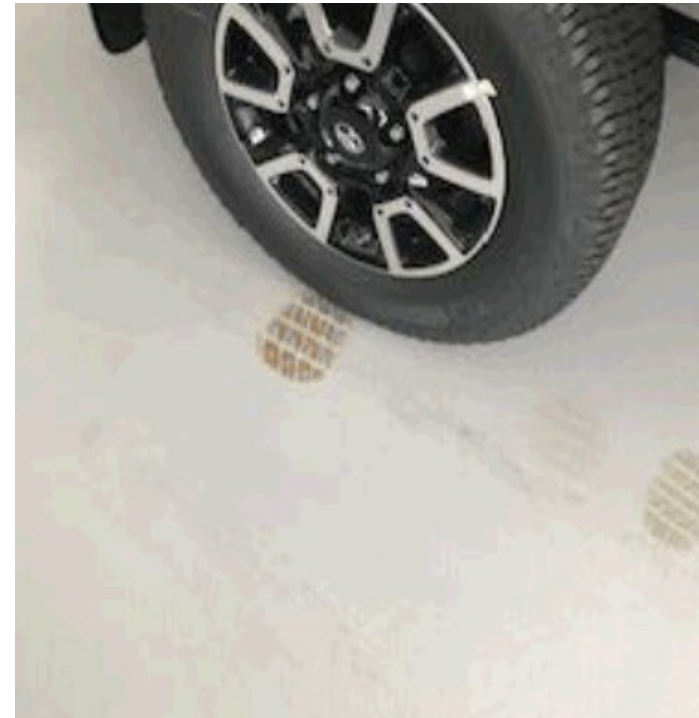
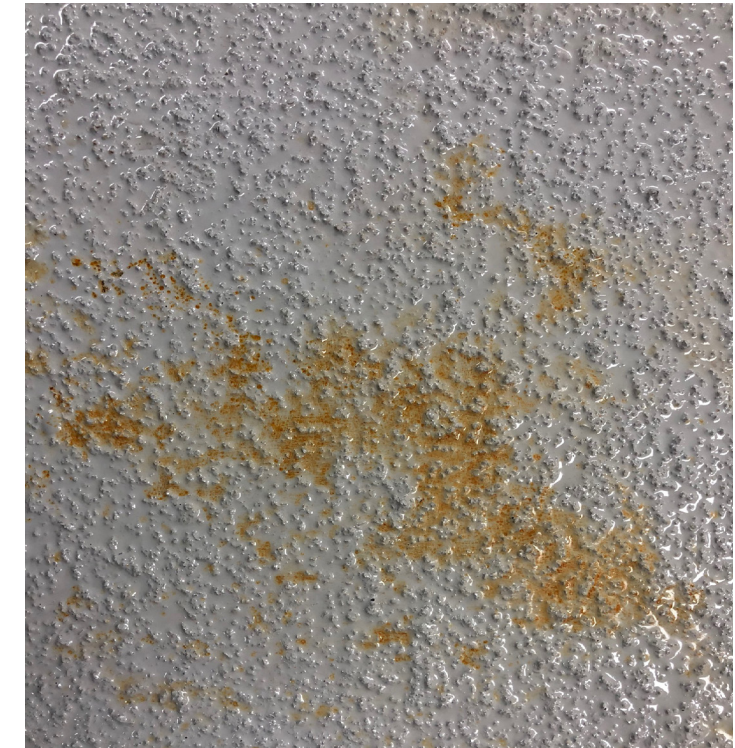
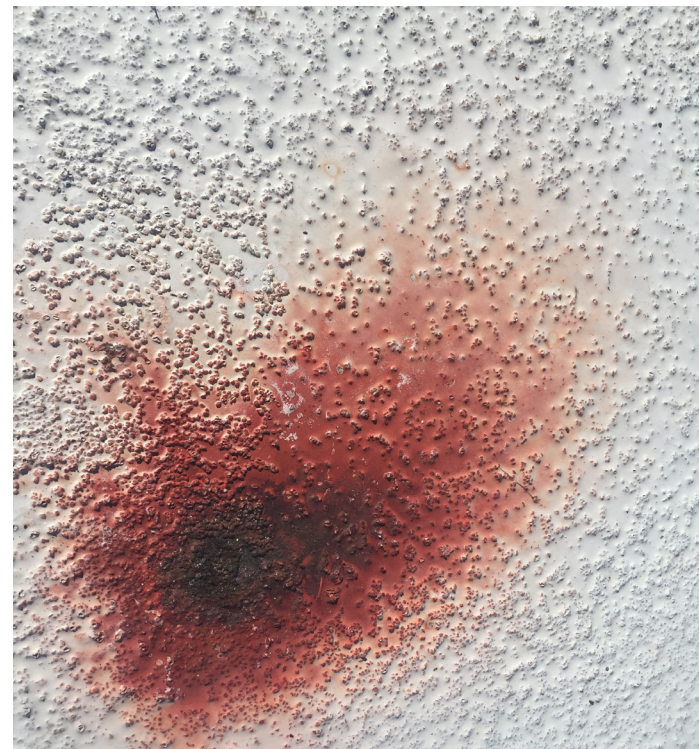
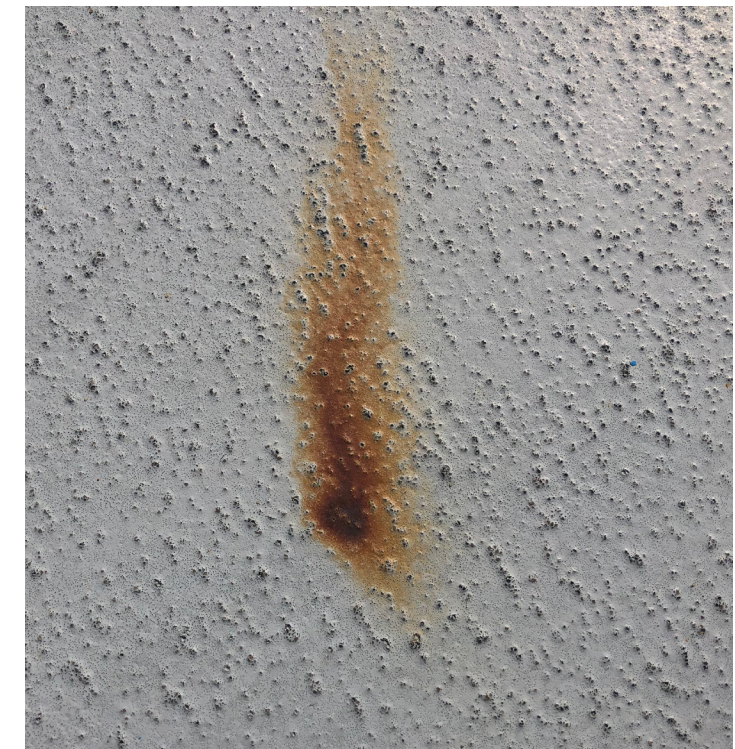
# STAINS

The coating has different discoloration stains.

- UV stability of top coat
- Staining due to auto liquids leak
- Metallic content in the aggregate - rusting
- Skid tire marks
- Tire marks due to longer contact with a new high performance tires (car dealerships)
- Insufficient maintenance and cleaning
- Insufficient mixing of component products

- Abrade affected area to remove the whole stain mechanically
- Clean and solvent wipe the whole affected area
- Apply recoat primer
- Apply additional top coat

- Check aggregate for metallic impurities (less than 0.05%)
- Clean the area after shotblasting
- Maintain and clean the deck periodically
- Clean car liquid spill within 24 hours period after first exposure
- Use protection pads under new performance tires when the car stays on one place for more than one week (car dealerships)
- Use aliphatic top coat only for UV exposed areas
- Use Sikalastic 748 Polypl

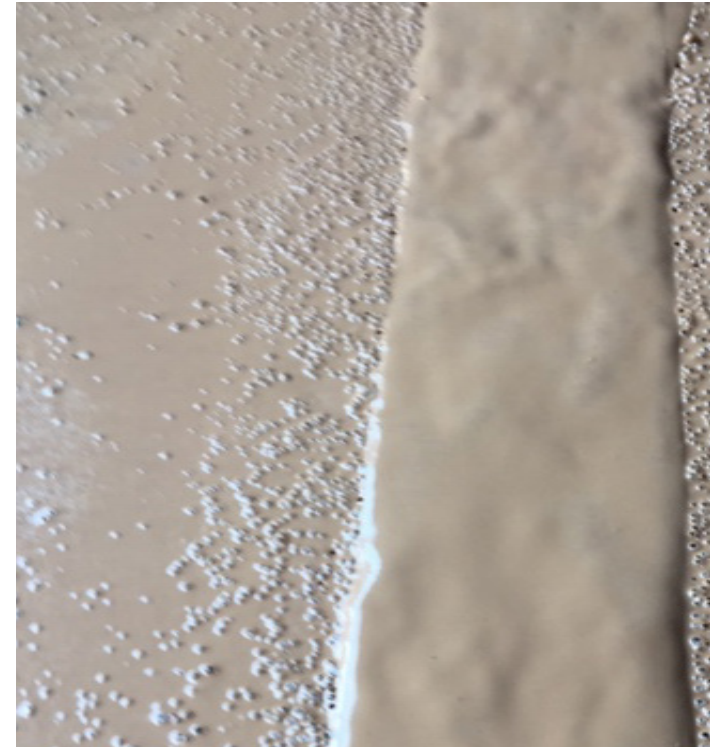
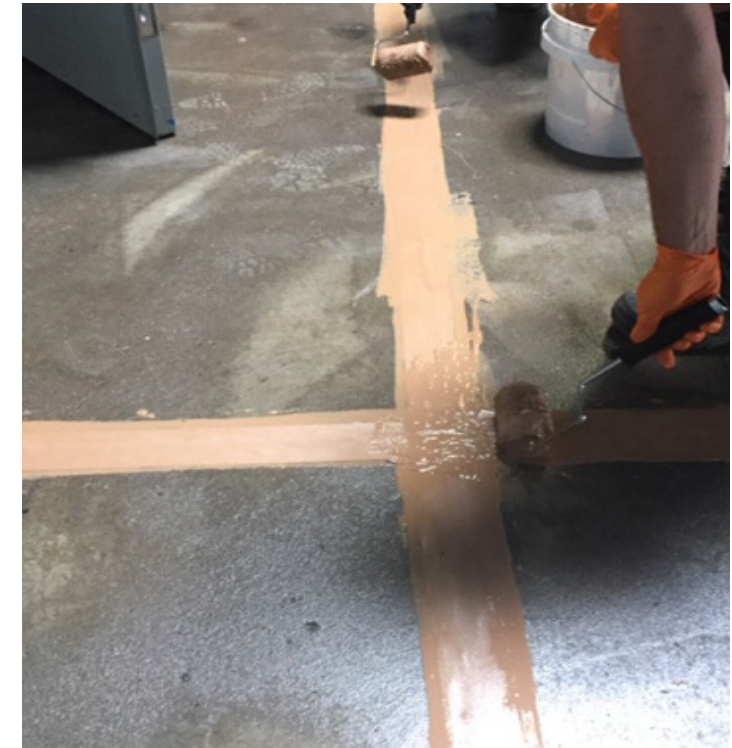
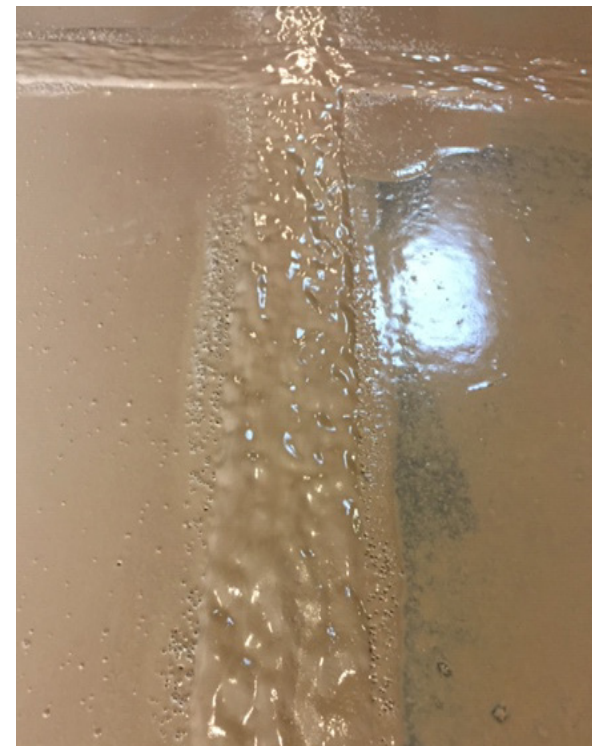
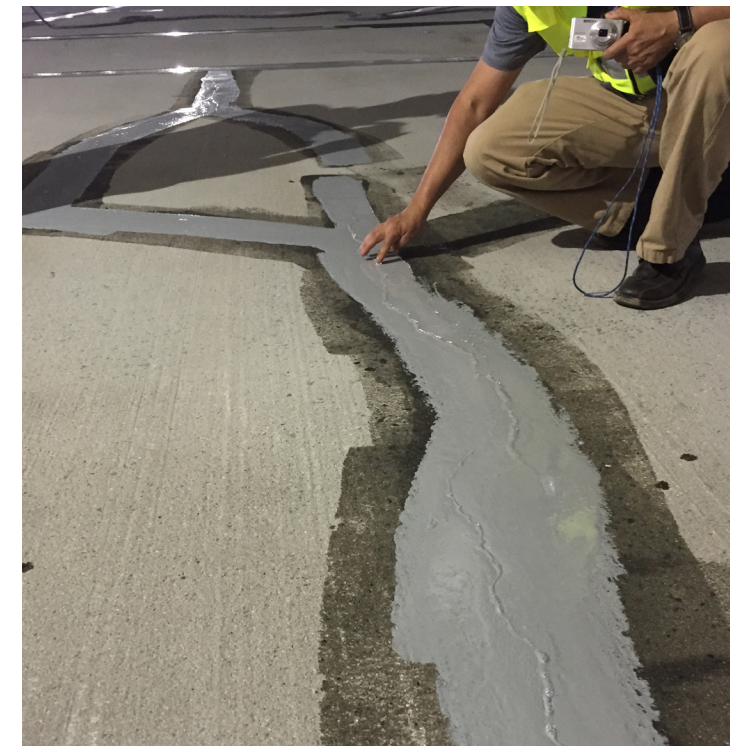
# GASSING UNDER REINFORCEMENT FABRIC

Big bubbles occur under fabric after the resin has been cured. When the fabric is cut the big air bubbles occur below. It happens mostly to reinforced detail coat especially when the coating was applied too thick prior to saturation of the fabric. The bubbles occur after 2-8 hours after the fabric was saturated in the resin.

- Wet film application is too thick
- Wrong tools
- Wrong detail work
- Uneven surface - low spots
- Very rough concrete surface profile ( more than CSP 4 )

- Completely remove affected area down to concrete substrate
- Re-apply the system with new reinforcement

- Check the wet film thickness during application
- Fill up and let cure low spot areas of the substrate before placing the fabric
- Check CSP ( CSP 2-4 required )
- The first coat to saturate the fabric should be thinner (10WFT max.) and then the fabric should be saturated with an extra resin from the top
- Check your tools
- Use a booster or accelerator with single component products
