# Traffic Membrane Troubleshooting Manual

**Technical Manual**

**2024 Edition**

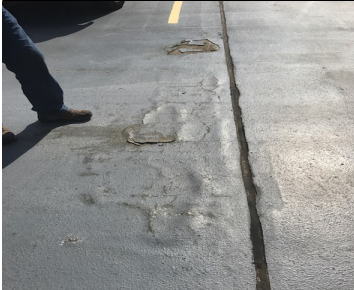
Bubbling Due to Encapsulated moisture in the substrate	Bubbles in the coating surface which have not popped. When the bubble is cut water comes out or the surface underneath the bubble is wet	3-4

- High surface moisture content prior to application of membrane
- Trapped moisture in insulated split slab construction
- Trapped moisture in metal pan deck construction
- Application during winter months – problem may not appear until the following summer when temperatures rise drawing moisture in the slab to the surface
- Water contamination prior to application of the coating ( rain )
- Application above 4% moisture content without using a special moisture barrier

- Completely remove affected area down to the concrete substrate
- Let the surface dry
- Re-apply the system paying special attention to avoid the causes listed above

- Check the substrate moisture content and follow the guidelines if the moisture is higher than 4% by Tramex. One more testing method to check vapor moisture drive strongly is recommended (plastic sheet test)
- Determine if the structure is a split slab or metal pan deck
- Check the dew point and ensure you are a minimum of 5F above the dew point
- Avoid outside application during late fall or winter (what about our winter grade?)
- Minimum temperature and humidity should be within the range specified in PDS
- If ambient conditions are critical apply the product during falling temperatures

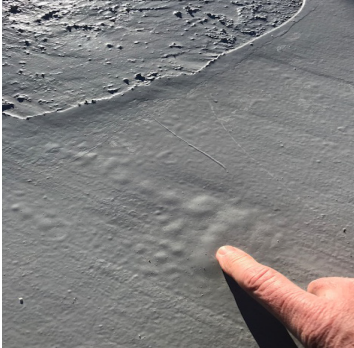
Blistering Due to Thick Coating	These blistering feel spongy and the coating is usually very thick and soft. When the blister is cut the coating is excessively thick and may be as much as 60-120 mils (DFT) thick and looks like a sponge with unbroken or circular blisters. It happens mostly to top coats especially single component top coats. The affected coating wears very quickly and aggregate usually settles completely into the coating leaving a smooth surface.	5-6

These blisters feel spongy and the coating is usually very thick and soft. When the blister is cut the coating is excessively thick and may be as much as 60-120 mils (DFT) thick and looks like a sponge with unbroken or circular blistering. It happens mostly to top coats especially single component top coats. The affected coating wears very quickly and aggregate usually settles completely into the coating leaving a smooth surface.

- Check the wet film thickness during application
- Detailing - Fill up low spot areas of the substrate prior to application
- Detailing - Check CSP ( CSP 3-4 required )
- During application backroll to move the material from low spot areas
- Check your tools - use the recommended size squeegee
- Use a booster or accelerator with single component products

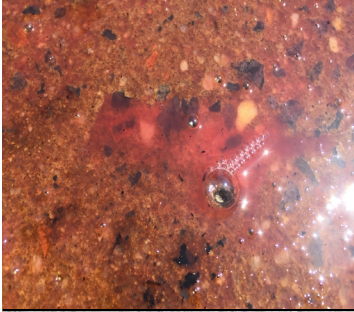
Pinholing/Bubbling	Pinholing is a result of outgassing when air escapes from porous concrete and becomes trapped in the coating. As the air escapes through the coating, the first sign is generally small bubbles that appear shortly after the application of the coating. When the bubbles pop they leave behind small craters in the coating. The pinhole can usually be seen at the bottom of these craters.	7-8

- Porous concrete surface
- Insufficient primer application
- Aggressive surface preparation
- Moisture ( damp substrate )
- High ambient temperature (rapid curing )
- Freshly applied coating exposed to direct sunlight
- High substrate temperature at 90°F and above

- Prime substrate precisely following required coverage rate
- If substrate is very porous or rough, 2 coats of primer are strongly recommended
- Avoid aggressive surface preparation
- Consider application in afternoons or evenings as temperatures are falling in order to avoid rapid temperature increase during application
- Prevent direct sunlight exposure during initial cure
- Temperature and humidity should be within the range specified in PDS
- At the first appearance of bubbles a spike roller can be used to pop the bubbles
- Check substrate moisture and follow the guidelines if the moisture is higher than 4% by Tramex.

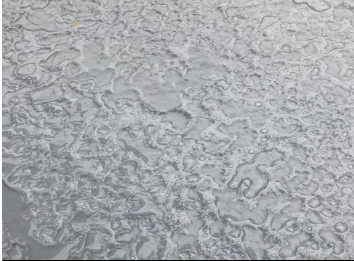
Water Damage	Water damage occurs as a result of deterioration of the membrane before the material has fully cured. This occurs when there is poor membrane adhesion due to the presence of water or dampness during the application.	9-10

Water damage occurs as a result of deterioration of the membrane before the material has fully cured. This occurs when there is poor membrane adhesion due to the presence of water or dampness during the application.

- Inclement weather during application (Rain, Snow)
- Accidental water leak (floors above, sprinklers)
- Human sweat
- Contamination by machinery liquids

- Avoid application during or shortly before anticipated inclement weather
- Protect the area from any potential accidental water leak from the floors above
- If possible, sequence the project from top levels to lower ones
- Workers should wear heats or head bands
- Deactivate sprinkler system prior to application

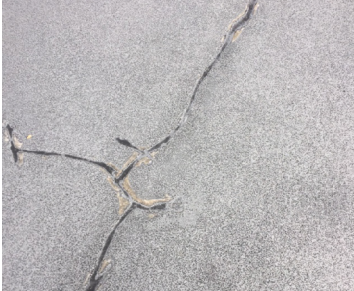
Cracks/Joints	Substrate fractures which telegraph through the membrane caused by excessive movement. Cracks may compromise the waterproofing system causing leaks affecting water tightness of the system if not properly treated.	11-12

Substrate fractures which telegraph through the membrane caused by excessive movement. Cracks may compromise the waterproofing system causing leaks affecting water tightness of the system if not properly treated.

- Structural problem - movement in the joint exceeds elongation of membrane
- Failure to route, caulk and detail every crack greater than 1/16"
- Failure to detail every crack which is less 1/16"
- Uncured sealant in routed and caulked crack
- Coating over joints greater than 1"
- Cracks in the concrete occur; especially in new construction, after the basecoat was applied

- Route existing cracks and seal with a polyurethane sealant
- Apply detail coat
- If excessive movement is expected reinforce detail coat with Sika Flexitape heavy or run the sealed joint through the traffic membrane

- Properly detail cracks
- The correct crack treatment will depend on crack width and expected movement
- Honor joints greater than 1" thorough the system
- The strip of detail coat 23 DFT should be always applied
- Use only PU sealant under PU waterproofing membrane
- Use reinforcement if movement creates crack up to 1/16 inch
- Rout and seal if movement creates crack between 1/16 inch to 1 inch

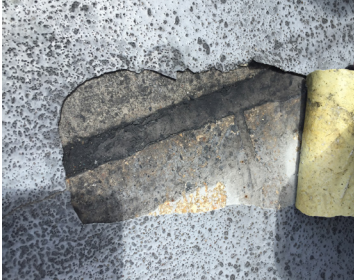
Delemation/Peeling	The coating peels off the substrate ( concrete ) or previous coat (inter coat adhesion).	13-14

- Insufficient concrete surface preparation ( suitable CSP )
- Existing coating preparation ( grinding, roughening, recoat window, cleaning, primer )
- Surface contamination ( dirt, dust, oil )
- Moisture ( damp substrate, dew point , sweat )
- Insufficient thickness ( min. DFT )
- Not properly maintained ( snow plows, aggressive cleaning agents, chemical impact – car liquid leaks )

- Remove loose delaminated coating
- Abrade and clean surface
- Remove all residual contamination (chemically or mechanically)
- Reapply the whole system or top coat using appropriate primers

- Follow PDS recommendations
- Surface preparation : Abrade or shot blast the substrate to achieve a CSP 3-4 per ICRI guidelines
- Surface contamination : Entirely clean substrate prior to application of primer or primerless base coat
- Remove all residual contamination on existing coating (chemically or mechanically)
- Remove all loose areas of existing coating
- Follow required maximum recoat window of new coating
- Follow required minimum coverage rates of each coat
- Check substrate moisture and follow the guidelines if the moisture is higher than 4% by Tramex
- Verify the substrate temperatures are minimally 5F above the dew point

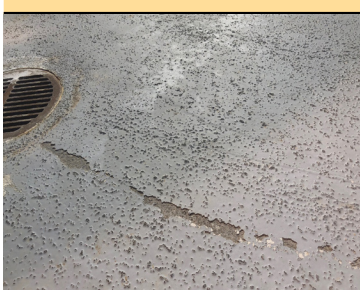
Mechanical Damage	Finished waterproofing system damaged by reckless use and insufficient maintenance .	15-16

Finished waterproofing system damaged by reckless use and insufficient maintenance .

- Reckless behavior
- Vandalism
- Snow plows
- Studded tires
- Skid marks - burned tires

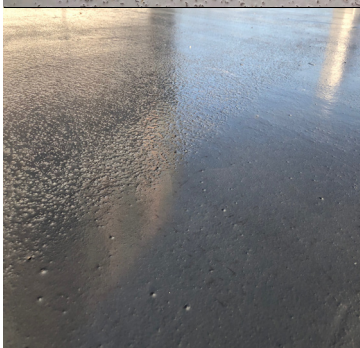
Skid Resistance and Inconsistant Texture	The surface of the finished membrane is slippery and/or there are 'bald' spots. Inconsistently seeded aggregate create bold and shiny spots on the membrane . Wear resistance and aesthetics features are also compromised.	17-18

The surface of the finished membrane is slippery and/or there are 'bald' spots. Inconsistently seeded aggregate create bold and shiny spots on the membrane. Wear resistance and aesthetics features are also compromised.

- Abrade the surface
- Clean and apply recoat primer
- Apply 2 coats of wear/top coat and broadcast depending on the type of seeding

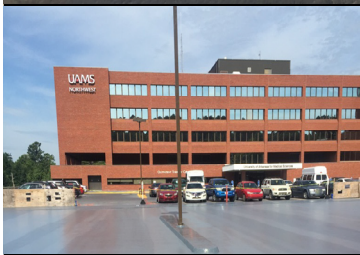
Color Variations	The coating appears to be different shades.	19-20

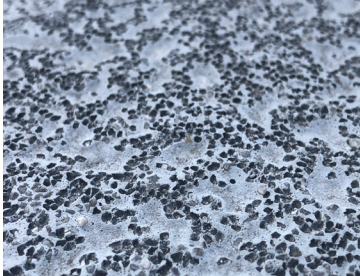
Aggregate Rolling Out	The top coat loses a significant aggregate after short a period of service.	21-22

- Clean the whole affected area from all loose aggregate and solvent wipe
- Apply recoat primer
- Apply 2 additional top coats seeded with right aggregate

- Check the source of aggregate and make sure that the aggregate is totally dry
- Aggregate can get wet if packed in plastic bags
- The aggregate should be washed silica sand
- Gradation of aggregate should be between 16 - 40 mesh
- Stock aggregate before application indoors or covered to protect from rain
- Follow the minimum and maximum thickness of the top coat
- Use textured products to avoid an issue with aggregate selection and aggregate condition

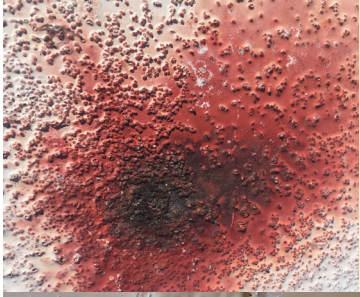
Stains	The coating has different discoloration stains	23-24

The coating has different discoloration stains.

- UV stability of top coat
- Staining due to auto liquids leak
- Metallic content in the aggregate - rusting
- Skid tire marks
- Tire marks due to longer contact with a new high performance tires (car dealerships)
- Insufficient maintenance and cleaning
- Insufficient mixing of component products

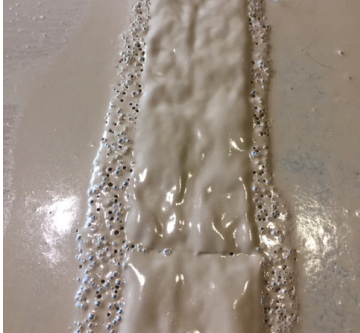
Gassing Under Reinforcement Fabric	Big bubbles occur under fabric after the resin has been cured. When the fabric is cut the big air bubbles occur below. It happens mostly to reinforced detail coat especially when the coating was applied too thick prior to saturation of the fabric. The bubbles occur after 2-8 hours after the fabric was saturated in the resin.	25-26
